**Re: Tree Preservation Order No 398 – 442 Glossop Road, Sheffield S10 2PX**

**Boundary Wall Adjoining  
1 Beech Hill Road, Sheffield. S10 2SA**

Prepared for            Mr P. Hattam  
Report Date            23<sup>rd</sup> January 2015  
Inspection Date        13<sup>th</sup> January 2015  
Prepared by            Dr M Seaton PhD BEng(Hons) CEng MStructE  
Occupation             Chartered Structural Engineer  
Signed                    *M Seaton*  
Date                        23-01-15

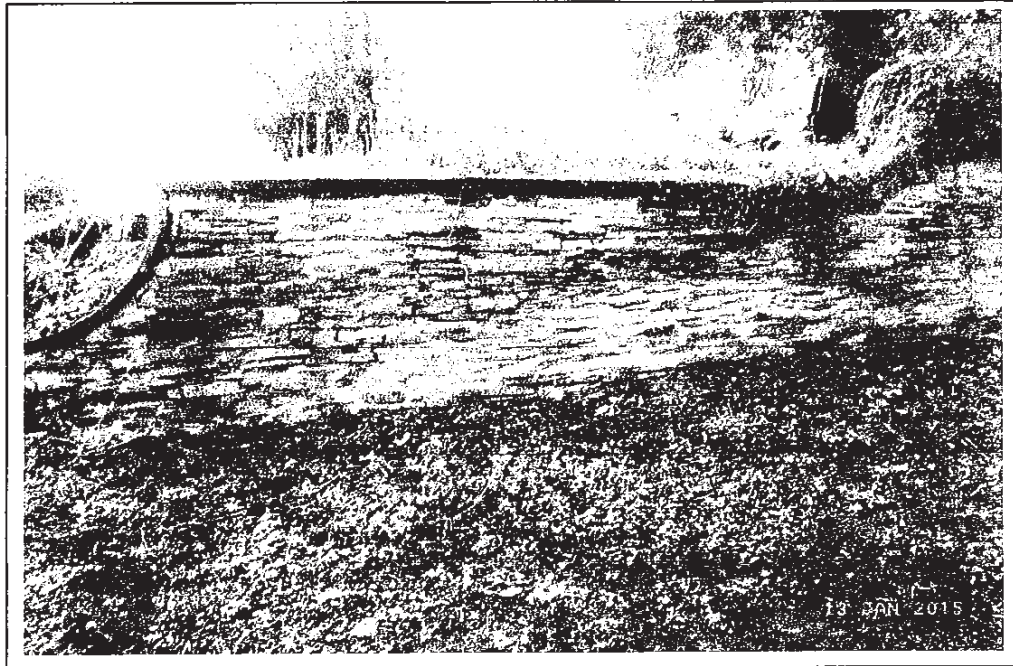
- 2.5 The wall is constructed in random un-coursed rubble sandstone, laid originally in a lime-sand mortar. The top of the wall is finished with the original sandstone coping stones and these have been shaped to follow the curved profile of the wall where the wall height steps on elevation; refer to Photograph 3.

- 3.1 Localised areas of the stonework have been repointed in the past and the pointing is unsightly and not to a good standard; furthermore the pointing appears to have used a strong cement-sand mortar which is not compatible with the relatively soft sandstone; refer to Photograph 3.
- 3.2 The base of the wall on the low side adjoining 1 Beech Hill Road is covered by a shallow soil slope leading down to the car park; refer to Photograph 4. It is considered that the soil has been retained in order to not undermine the base of the wall when the original car park was created.
- 3.3 Immediately adjacent to the high side of the boundary retaining wall there are two mature Lime trees and a holly tree. The Lime trees are covered in ivy and do not appear to be in particularly good condition; refer to Photograph 5 & 6.

- 4.1 It is considered that the wall construction is original, dating the wall at over 150 years old. Other than some evidence of re-pointing, there is no indication that the wall has been altered from the original construction. The re-pointing to areas of the wall with cementitious mortar will be detrimental to the continued durability of the wall construction and weathering of the stonework. Furthermore, the original wall construction will have been relatively free draining, while the later cement-sand pointing will be impervious, allowing water pressure to build up behind the wall.

**Photograph 3:**  
Showing General Condition of Wall and Areas of Unsightly Re-pointing.

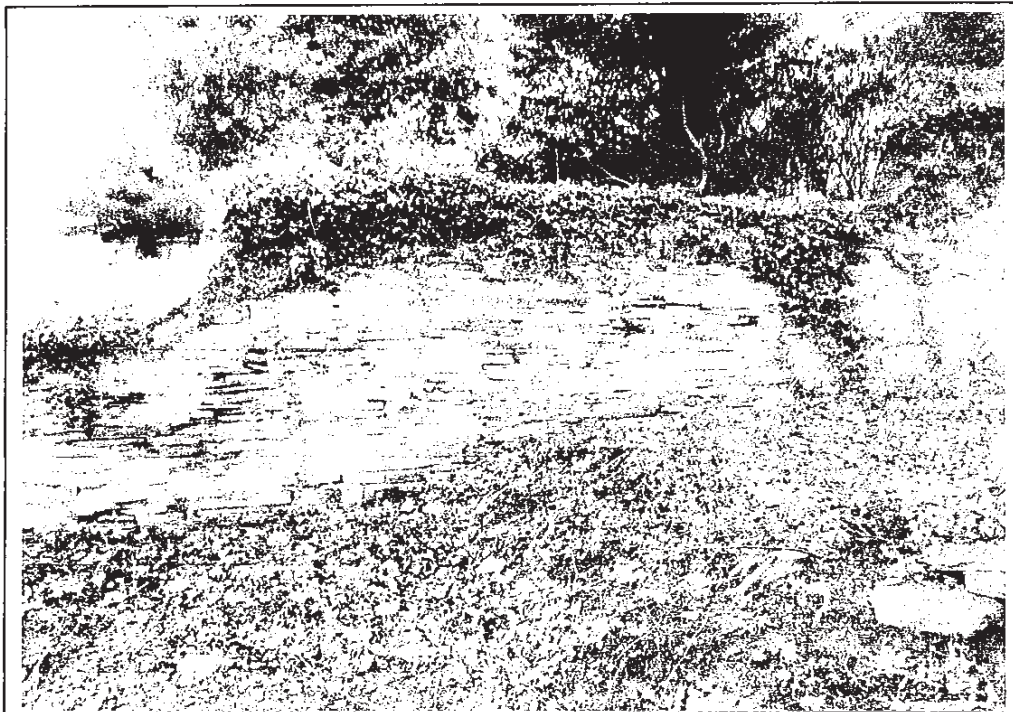
- 4.4 The earth slope in front of the base of the wall to the low side, discussed in Paragraph 3.2, appears to have been retained in order to cover the base of the wall. It is considered however that the depth of this fill material is not sufficient to protect the wall foundation from the influence of frost. Furthermore, there is insufficient mass of fill material at the base of the wall to resist lateral pressures exerted by the retained material behind the wall. It is therefore recommended that the foundations to new wall should be taken deeper and subsequently the new wall stem should be designed to take account of the increase in retained height. Similarly the raised ground level on the high side of the wall, discussed in Section 3.4, will cause an increased surcharge loading on the back of the retaining wall and this will also need to be taken into consideration when designing the new retaining wall.

**Photograph 4:**  
Showing Retained Soil Slope to Base of Wall.

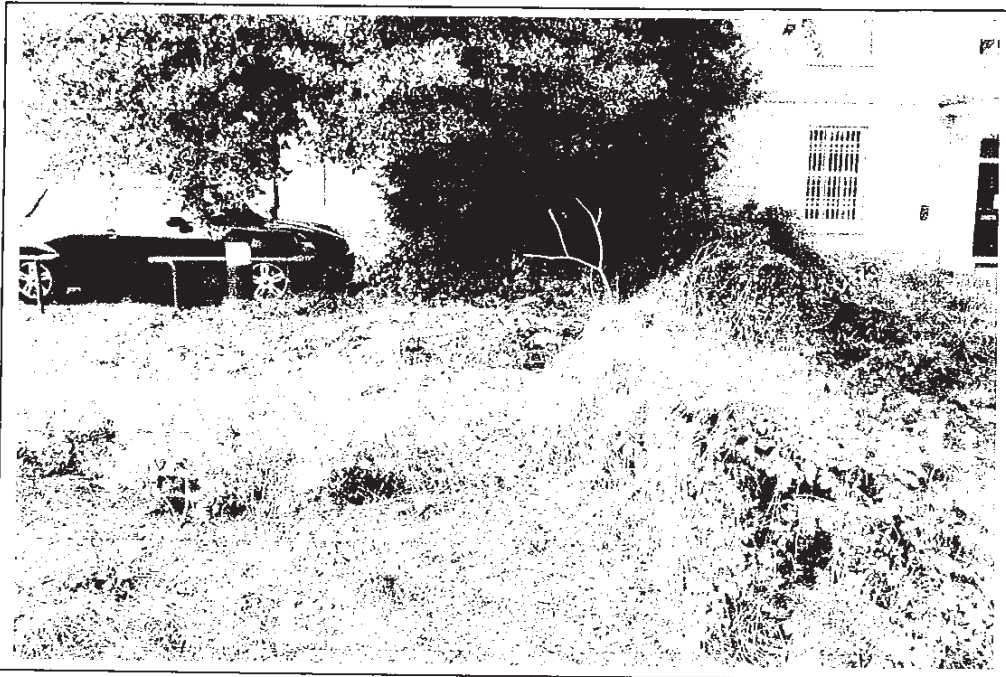
- 4.2 The large Lime trees immediately behind the wall further threaten the long-term stability of the wall due to increased surcharge loading, mechanical root action and leverage of the wall under wind action. Furthermore, the position of the trees present a logistical problem when considering reconstruction of the wall, since removal of the wall could compromise the stability of the root ball. It is therefore recommended that the trees should be removed as they are reliant on support from the retaining wall, the condition of which is questionable.

**Photograph 5:**  
Showing Ground Level on High Side of Wall and Proximity of Trees to Rear of Wall.

- 5.1 Permission to remove the two Lime trees should be obtained at the earliest opportunity and prior to developing a detailed design for the retaining wall.

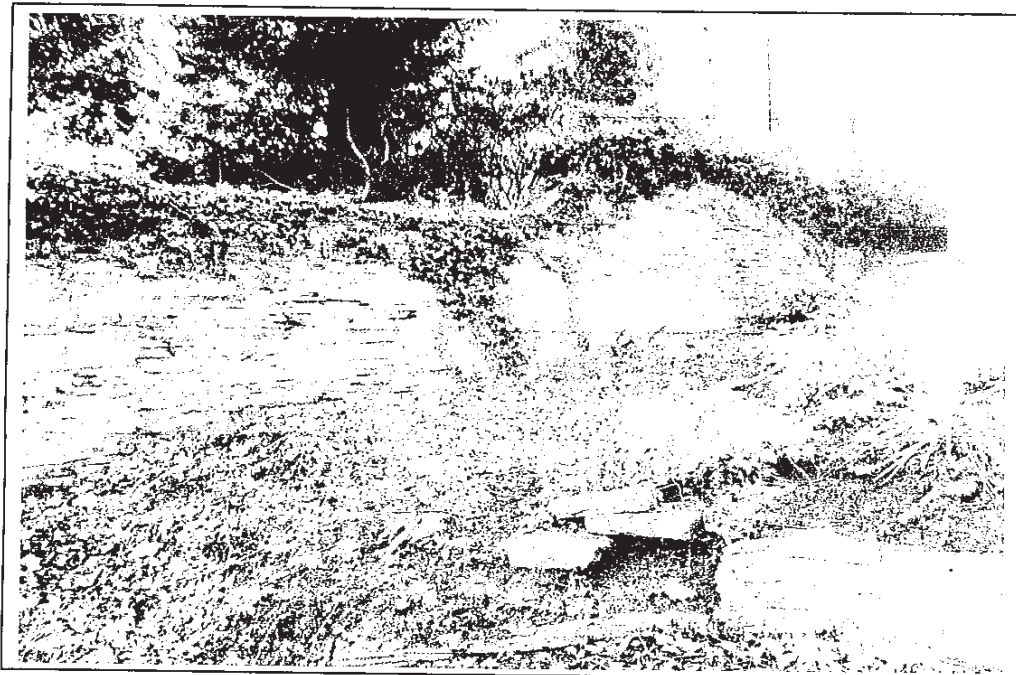
**Photograph 6:**  
Showing Proximity of Lime Trees to Wall and Existing Buildings.

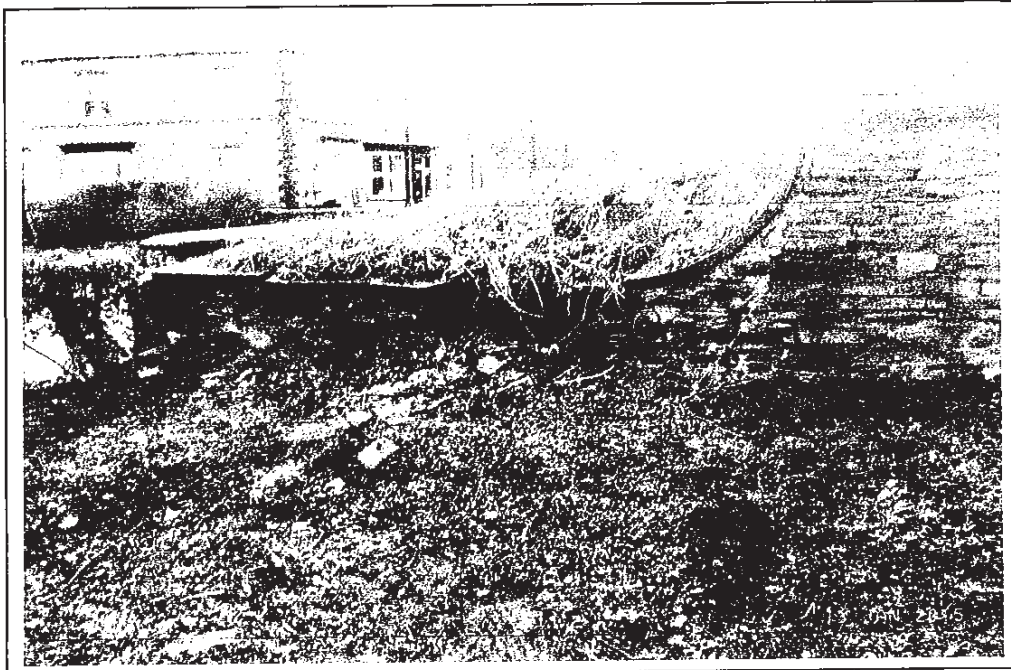
- 3.4 A section of the wall towards the Glossop Road end has collapsed and several of the stones have fallen out; refer to Photograph 7. In this location the ground level to the higher side of the wall has been artificially raised at some time in the past. There is evidence that an improvised retaining wall, in the form of large stone boulders, has been constructed on top of the wall to retain the raised ground level; this will have placed an increased surcharge load on the back of the retaining wall.

**Photograph 7:**  
Showing Collapsed Section of Wall and Raised Ground Levels Above.

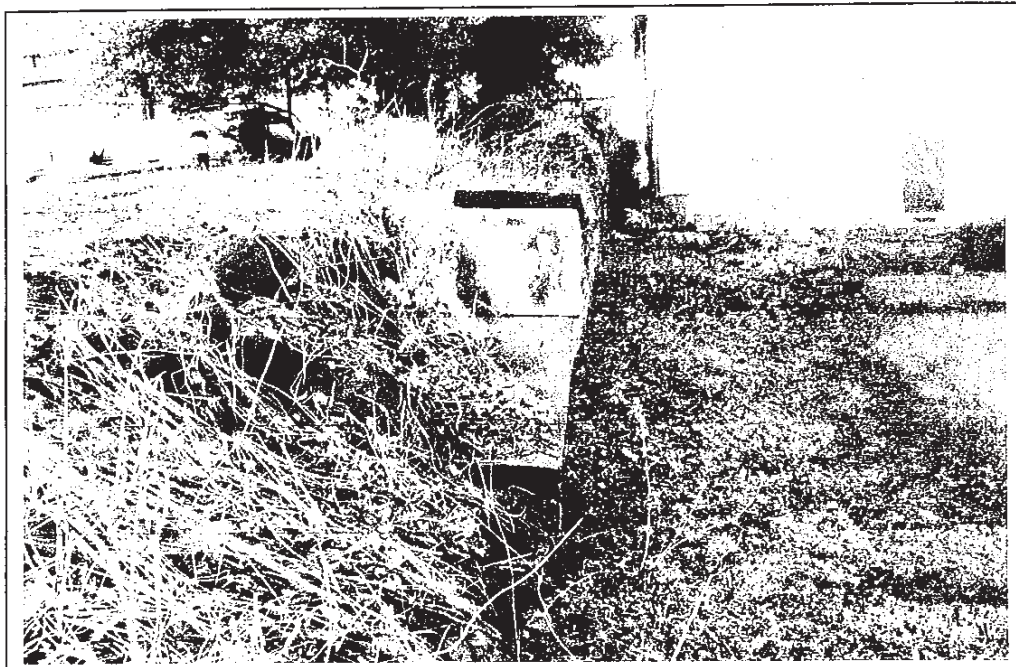
- 3.5 The vertical profile of the wall varies along its length due to bulges in the stonework and a general tilt towards the car park on the low side; refer to Photograph 8. At the point of maximum displacement the verticality of the wall was measured using an 1800mm long spirit level and this demonstrated an eccentricity of approximately 170mm over the length of the spirit level; representing an angle of tilt of approximately 5.5 degrees; refer to Photograph 9.

**Photograph 8:**  
Showing General Outward Lean of Retaining Wall.

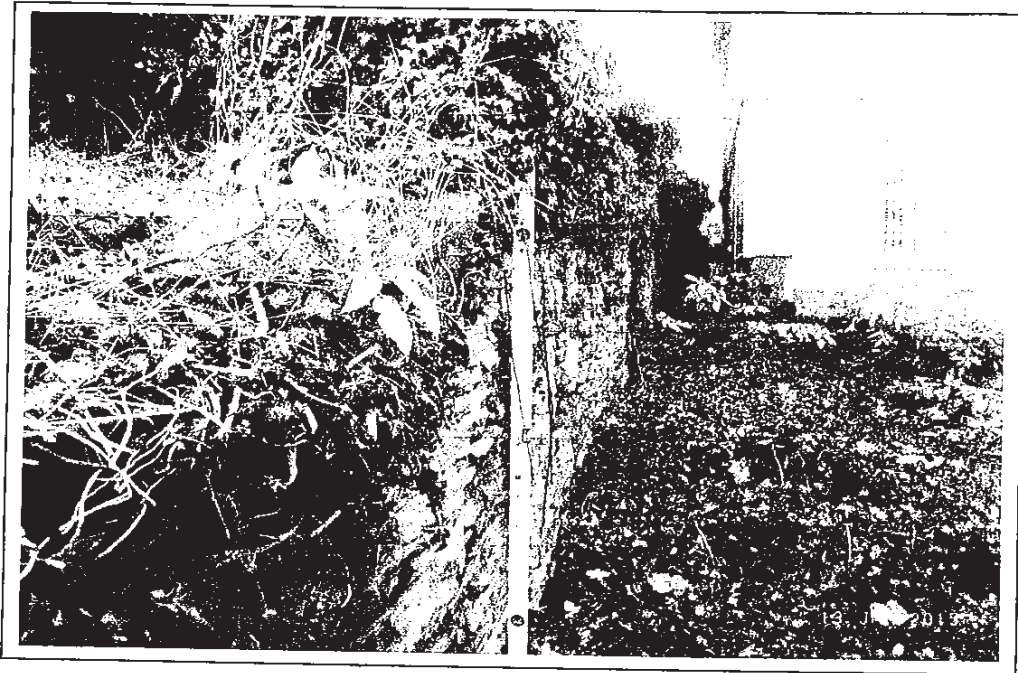
- 4.3 The overall thickness of the wall is approximately 350mm, however it is not known whether the wall increases in cross-section below the upper ground level. The degree of eccentricity of 170mm shows that the centre of gravity of the wall is outside the middle-third of the assumed overall thickness, indicating that the wall is unstable and vulnerable to collapse.

**Photograph 9:**  
Showing Lean of Retaining Wall Relative to an 1800mm Long Spirit Level.

- 5.2 Once the trees have been removed the existing boundary wall should be taken down and the existing coping stones should be carefully marked and set aside for re-use. Similarly the existing sandstone blocks should also be retained and cleaned for re-use.

- 5.3 The existing ground should be battered back in order to form a stable slope and a new concrete foundation should be constructed in accordance with the design specification. Two leaves of blockwork should then be constructed off the foundation and the cavity between the leaves infilled with reinforced concrete, to form a reinforced stem. Once the concrete has gained sufficient strength the rear of the wall should be backfilled with free draining granular material. The front face of the wall should then be faced up using the existing sandstone laid in a hydraulic lime-sand mortar to match the existing. The original sandstone coping stones should then be re-bedded in their original sequence.
