John Lewis, Sheffield Phase 1 Commission Sheffield City Council

The scope of this commission was to provide the Sheffield City Council with

Desk Top Review

Observations

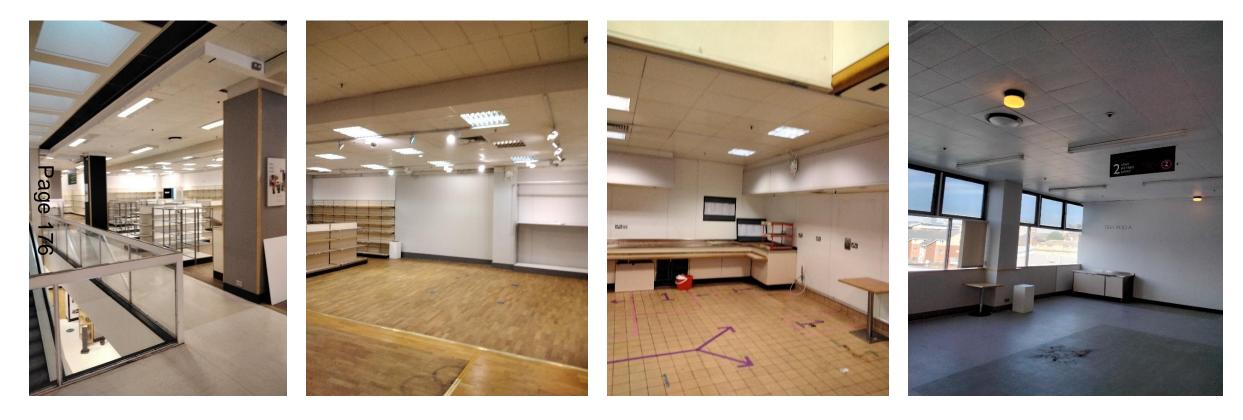
- Materials were generally in good condition, encapsulated and labelled and no damage was apparent during the walk round, however decanting
- Dust and debris contained within ceiling voids, ceilings were not displaced or damaged at the time of the site visit.

Image sales area

Back of house area

- In order to be fully satisfied that all areas of the building are safe to access, it would be prudent to undertake reassurance air tests when JLP have decanted the building to the following areas
 - Sales floors on all floors beneath ceiling tiles.
 - Second floor kitchen
 - Second floor male toilet
 - 4th floor air handling unit
 - Basement stock rooms
 - Basement boiler room/stock room/plant room and associated stores areas.

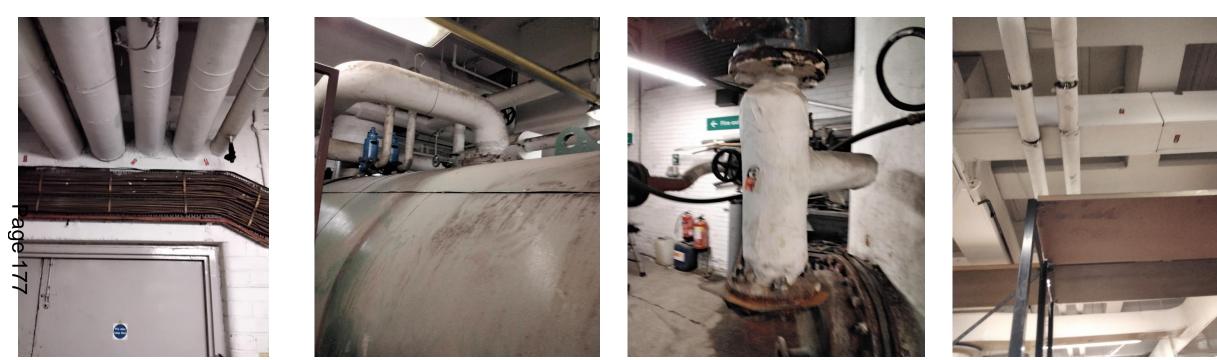
Lagged Pipework

Lagged Boiler

AIB to beams

- Compile technical specification for the soft strip and safe removal of ALL ACMs identified in Socotec report and any supplementary report/inspections.
- > Issue to SCC to issue as part of the tender documentation to Principal Contractors.
