John Lewis Building Condition Assessment

Sheffield City Council

Summary Report

November 2021 Rev A

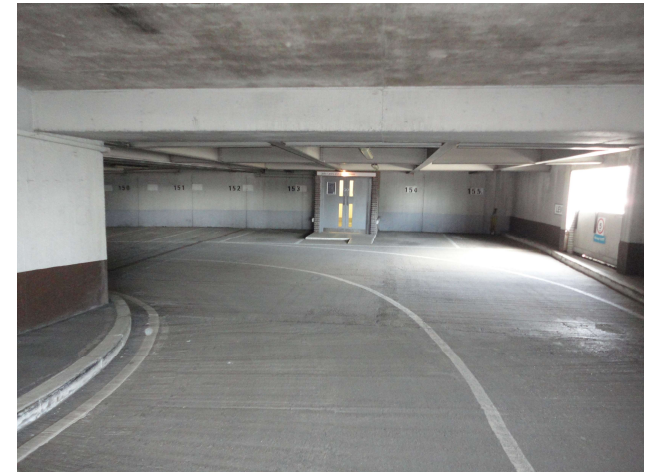
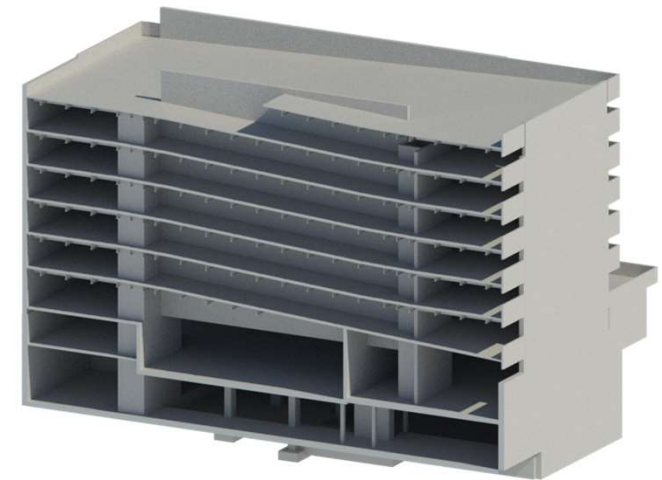
The car park is in a much poorer condition than the main store and there are numerous elements of cracking and spalling of the concrete. The steel beams have areas of corrosion that has removed the corrosion protection and also the intumescent paint that provides the fire protection to the structure.

The de-icing salts used over the years have corroded the concrete structure. The chloride ingress has resulted in significant areas of deterioration. Significant repair works and maintenance would be required over the next 25 years

The car park is not in good condition and would require significant repair and ongoing maintenance over a 25year period. In conjunction with reducing car parking demand with John Lewis vacating, we would recommend that serious consideration is given to demolition of the car park in any redevelopment option.
