## **John Lewis, Sheffield Phase 1 Commission Sheffield City Council**

# Socotec Commission (JLP) & Overview

# Tersus (Desk Top Review)

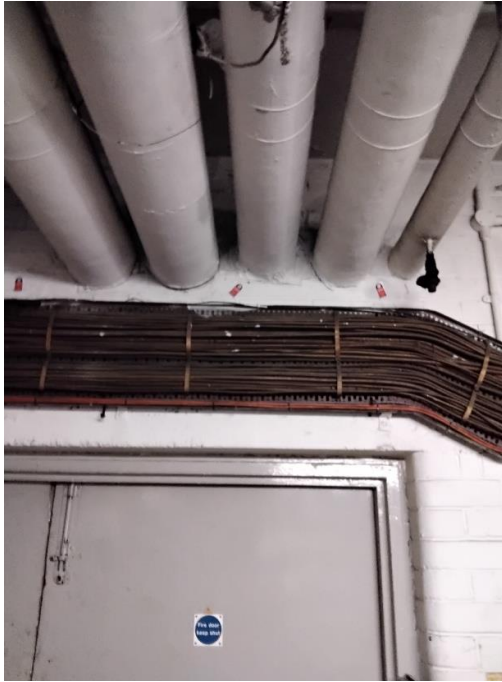
Lagged Pipework

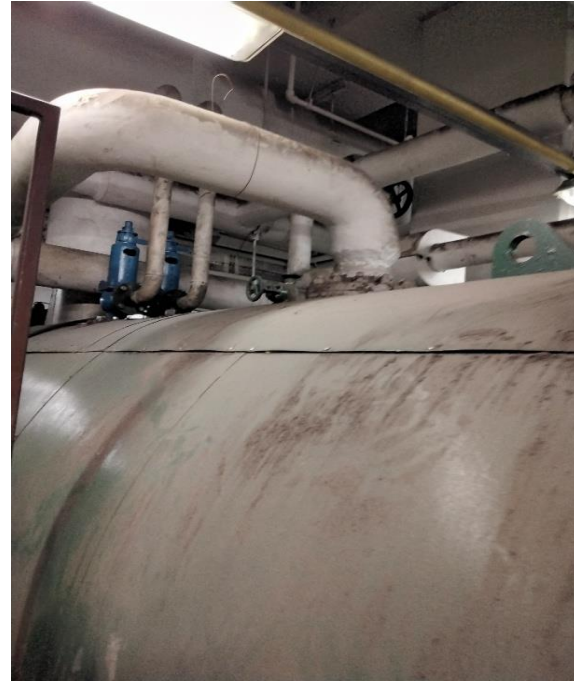
Lagged Boiler

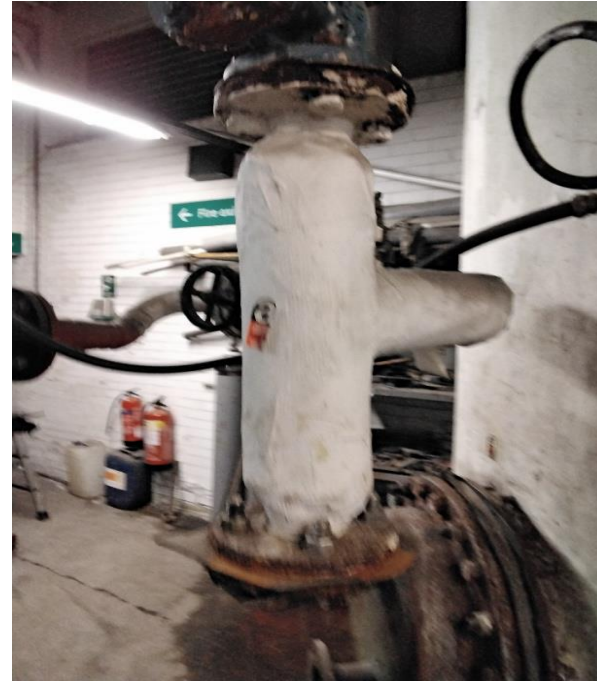
Lagged Pipework

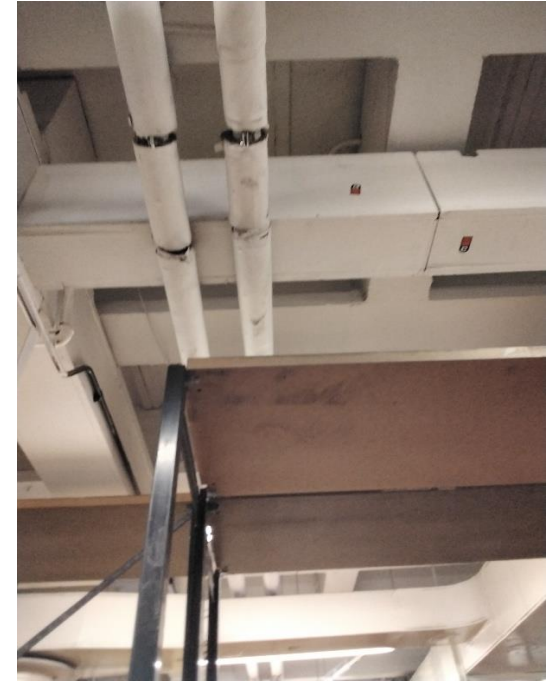
AIB to beams
