REPORT TO PLANNING AND HIGHWAYS COMMITTEE

5 NOVEMBER 2013

ENFORCEMENT REPORT

UNAUTHORISED REPLACEMENT OF WINDOWS TO THE FRONT AND SIDE OF 263 CEMETERY ROAD, S11 FACING GRANGE CRESCENT ROAD AND CEMETERY ROAD, THE ERECTION OF A NEW SOIL PIPE FACING CEMETERY ROAD, A NEW DOWN PIPE ADJACENT TO THE BAY WINDOW FACING GRANGE CRESCENT ROAD, THE REPLACEMENT OF GUTTERING AND THE ERECTION OF ROOF FELT ON THE GROUND FLOOR BAY WINDOWS.

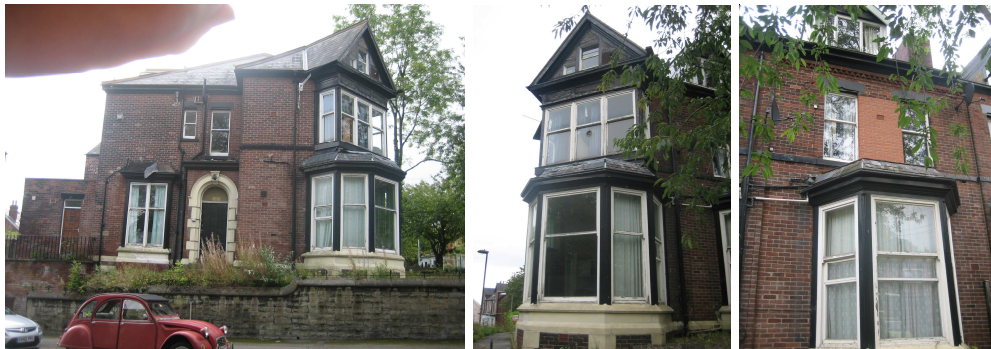
Before changes photographs taken in September 2011

- 3.6 The previous windows were original timber sliding sash. The replacement windows are now all white UPVC either top or bottom hung opening.
 - 3.7 It is considered that the unauthorised new UPVC windows are of an unsatisfactory appearance due to the poor design and detailing. The traditional styles of windows in this area were timber sliding sash. One of the most important aspects of these are the top sash that projects over the bottom sash and the method of opening which has not been replicated in these replacements. This has the effect of a flush appearance. The second important characteristic is the slender box frame. The replacements have lost this slender detail and have a much heavier chunky appearance to the frames. As the windows have

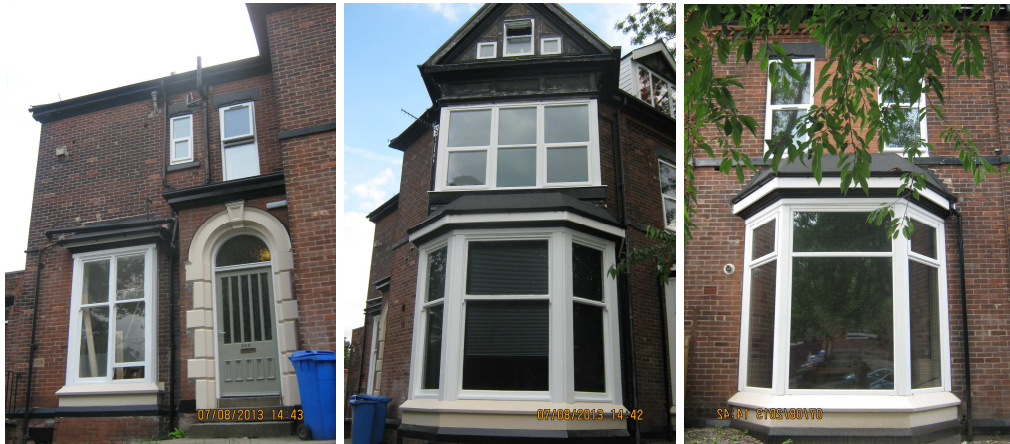
After changes photograph taken in August 2013

a non-traditional method of opening this is further exacerbated when the windows are left in the open position.

- 3.9 The new black UPVC soil pipe, black UPVC guttering and the roof felt on the bay windows have been installed. UPVC and roof felt which is normally manufactured from bitumen are materials not traditional to the area and are considered to be unacceptable in a conservation area, where traditional natural materials are required by Policy BE17 of the UDP. The rainwater goods would traditionally be cast iron, and painted timber and lead would be the appropriate material for the top of the bay window.

- 3.12 Given the circumstances the windows and the new soil pipe, guttering, down pipe and the roof felt on the bays fail to preserve or enhance the character of Nether Edge Conservation Area and as a result are contrary to the aims of the policies BE5, BE15, BE16, BE17 and H14 of the Unitary Development Plan.

- 3.14 As the windows replaced at 263 Cemetery Road were traditional timber, sliding sash windows, their loss and replacement with UPVC windows represents a clear erosion of character, and a very different case to the appeal described above.
- 3.15 The photo images below show the property in question before and after the changes and clearly demonstrate that the unauthorised windows and the new soil pipe, guttering, down pipe and roof felt on the bay windows are not appropriate for the property and their appearance is deemed not to be in keeping with the character of the Conservation Area.

- 3.16 The Enforcement Notice would require the removal of the unauthorised ground floor bay window facing Grange Crescent, all the windows on the first and second floor elevation, the removal of guttering, down pipe and roof felt on the ground floor bays and the removal of the unauthorised soil pipe facing Cemetery Road within a specified time period.

- 8.1 That authority be given to the Director of Regeneration & Development Services or the Head of Planning to take all necessary steps, including enforcement action and the institution of legal proceedings, if necessary, to secure the removal of the unauthorised ground floor bay window facing Grange Crescent and all the windows at first and second floor, soil pipe, guttering, down pipe and roof felt.
- 8.2 The Head of Planning is delegated to vary the action authorised in order to achieve the objectives hereby confirmed, including taking action to resolve any associated breaches of planning control.
