SHEFFIELD CITY COUNCILAgenda Item 8 **PLACE**

REPORT OF	DIRECTOR OF DEVELOPMENT SERVICES	ITEM	
SUBJECT	ENFORCEMENT REPORT		
	UNAUTHORISED REPLACEMENT OF WINDOWS AND BOUNDARY WALL TO THE FRONT OF ALBANY ROAD. S7.

ENFORCEMENT REPORT

UNAUTHORISED REPLACEMENT WINDOWS AND BOUNDARY WALL TO THE FRONT OF THE DWELLING AT 20 ALBANY ROAD WHICH LIES WITHIN THE NETHER EDGE ARTICLE 4 CONSERVATION AREA

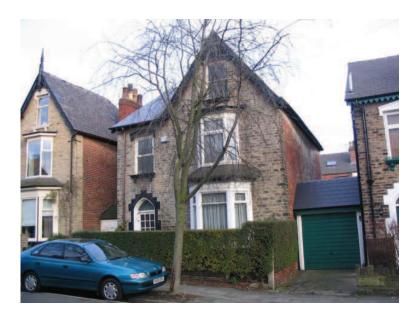
Original Windows and Frontage – December 2005

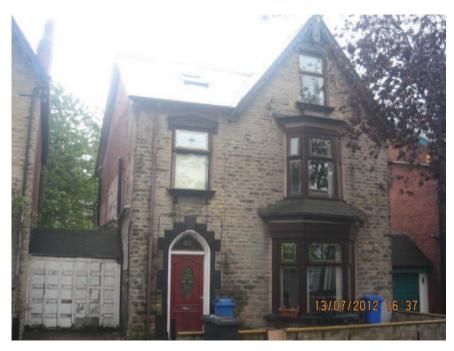
- 2.2 The Council was first alerted that workmen were converting the house into separate flats and taking out the windows on 2nd October 2008. A visit to the site was made that day and officers witnessed interior work being carried out on the house but the traditional windows had already been replaced with new Brown uPVC windows not considered to be in keeping with the character of the Article 4 Conservation Area.

- 2.5 In December 2008 a further phone call was received from a neighbour advising that the original small front boundary wall and the hedging had now been replaced by a breeze block wall. Again this wall is unauthorised and not in keeping with the character of the Conservation area. Officers also noticed a velux window had been installed on the roof on the front elevation, which had also been fitted post the Article 4 restrictions.

Replacement Windows and Wall Frontage

although not sash opening. These traditional style sash windows are an important feature in the many Victorian and Edwardian villas within the Nether Edge Conservation Area. The replacements are all however brown uPVC frames with detailing on the glass and all non sash opening, which have a detrimental appearance on the house.

- 3.2 The installation of the breeze block wall at the front of the house is an inappropriate boundary treatment that should be replaced by a wall of more traditional materials such as stone or brick.
- 3.3 The installation of the velux window is considered to be acceptable due to its limited impact.
- 3.4 The Local Planning Authority consider that the retention of the uPVC windows as installed and the front boundary wall by reason of their external appearance, poor detailing and material, gives rise to an unsatisfactory appearance, and therefore fails to preserve or enhance the character of the Nether Edge Conservation Area and is therefore contrary to the aims of policies BE5, BE15 and BE17 of the Unitary Development Plan

- 4.2 Section 172 of the Act provides for the service of an enforcement notice, (EN). In this case such a notice would require remedial measure to ensure that the perceived harm is remedied. In this case this would be that the Windows should be replaced with wooden sash windows substantially similar to those removed and the front boundary wall should be replaced with a treatment substantially similar to that previously in place.

7.1 That the Director of Development Services or Head of Planning be authorised to take any appropriate action including, if necessary, enforcement action, and the institution of legal proceedings to secure the removal of the unauthorised windows, excluding the velux window in the roof, and boundary wall to the front of 20 Albany Road.
