SHEFFIELD CITY COUNCIL

Planning & Highways Committee Report

Subject: Tree Preservation Order No. 471

The Limes 7a Endcliffe Hall Avenue, Sheffield, S10 3EL

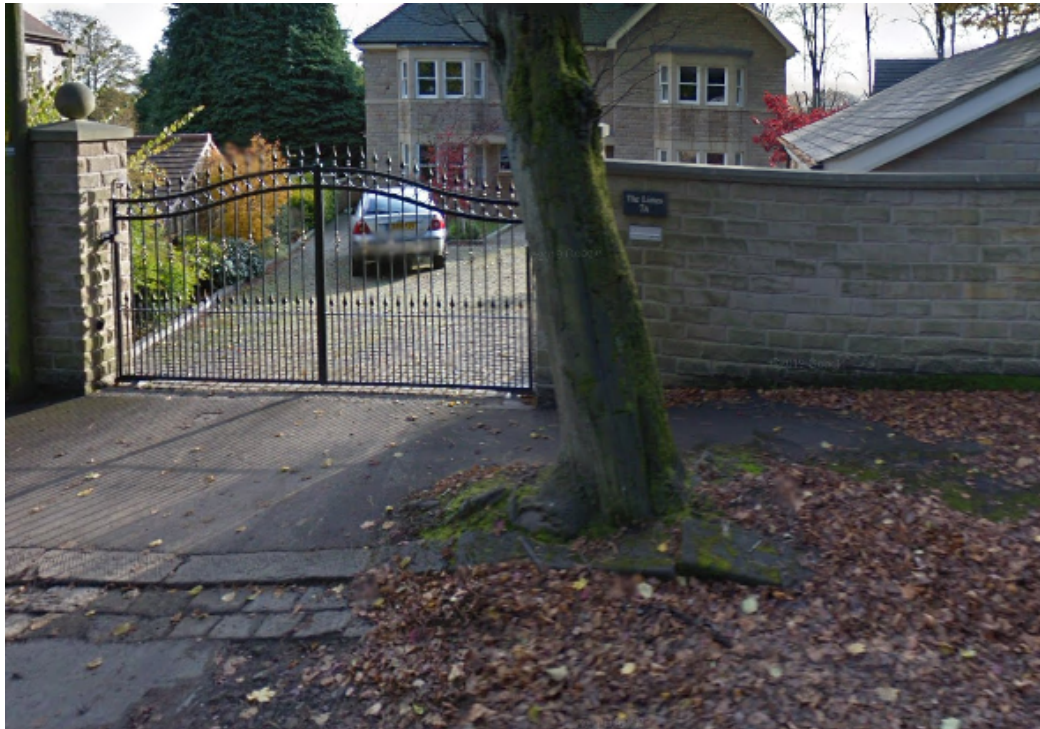
Images showing lack of movement in kerb profile between 2012 and 2022.

Google Streetview. November 2012. Raised kerb at the foot of the tree.

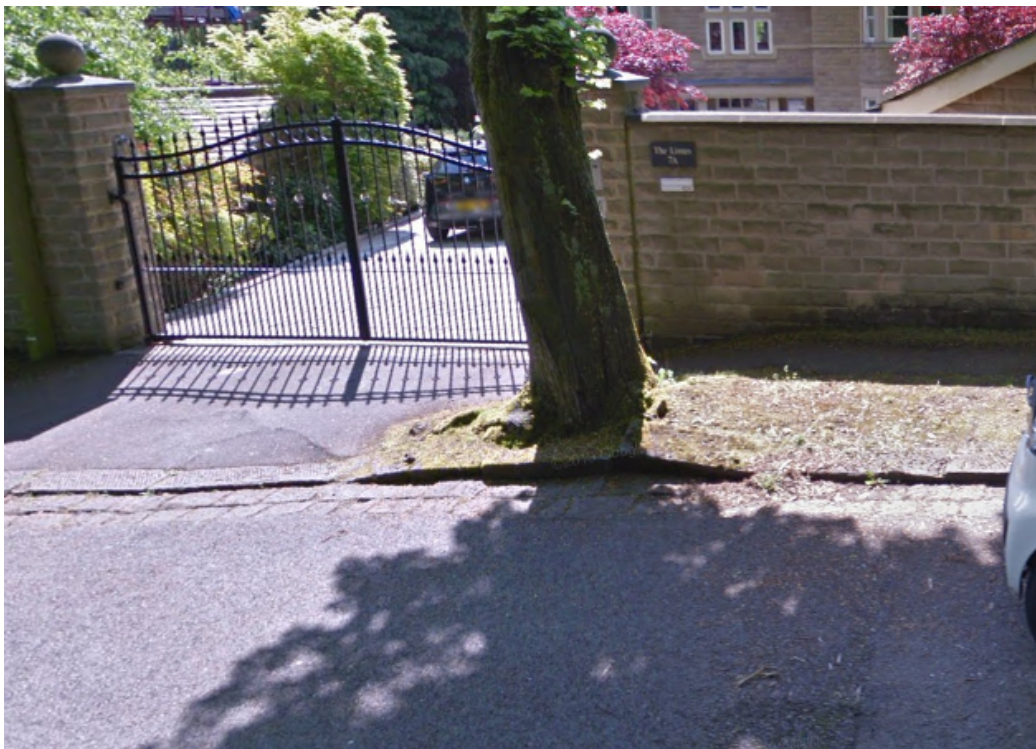
Google Streetview. May 2019. No substantial change to kerb alignment

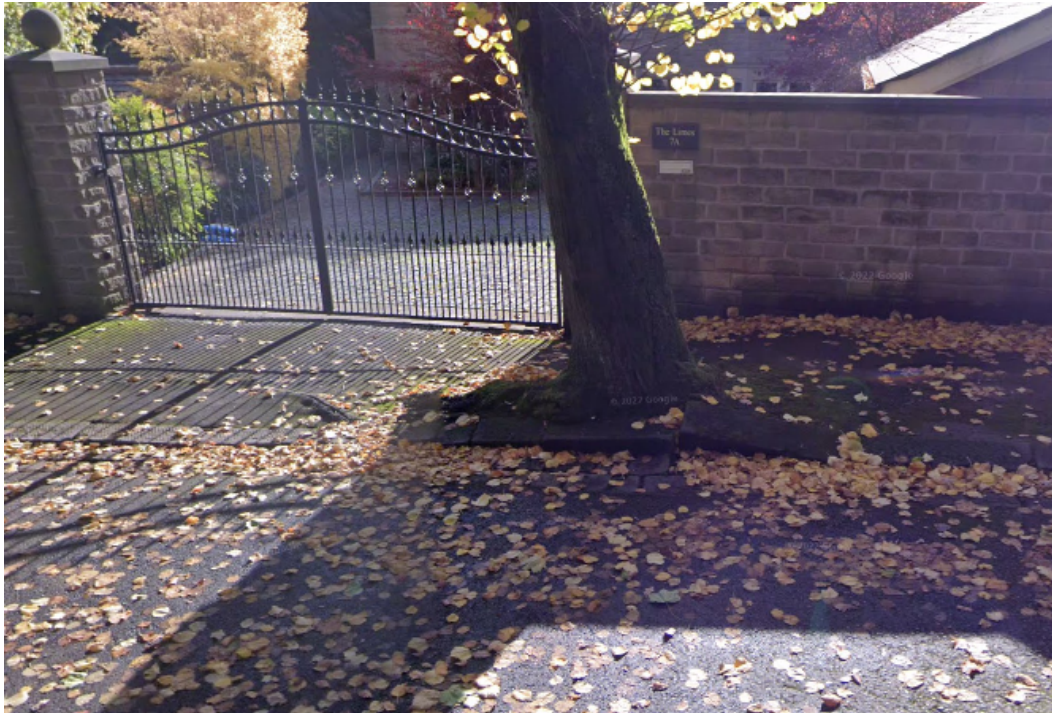
Streetview October 2022, taken after the high wind event of January 2022, which allegedly caused the tree to move. Tree inspected on 28th February 2023. No indication typical of tree movement was present. Comparison of Streetview photographs show no evidence of movement in kerb profile between 2012 and present day.

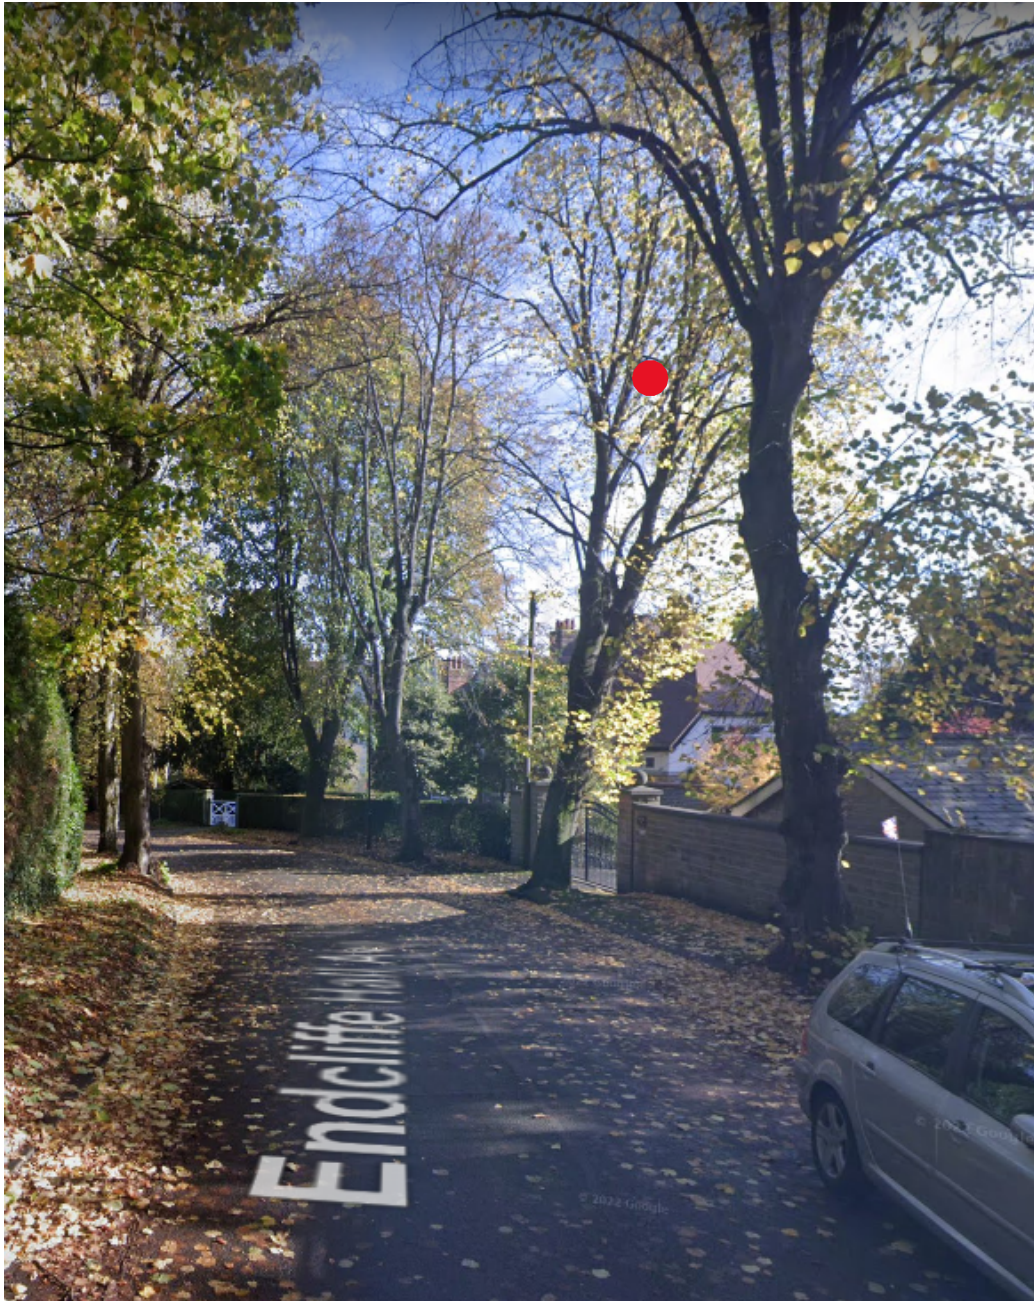
<p>Score & Notes :</p> <p>3. Previously pruned. Tree leans at a 33 degree angle. No signs of recent movement visible during inspection. Comparison of google streetview photographs between 2008 and present day show no change in the angle of the stem, or changes to the angle of upper canopy structure that would indicate movement had occurred.</p>
--

Google Streetview October 2022. No discernible change in angle of the tree
