COISLEY HILL, WOODHOUSE PROPOSED ZEBRA CROSSING

ROAD SAFETY AUDIT STAGE 1 [PRELIMINARY DESIGN]

**DEVELOPMENT SERVICES
TRANSPORT, TRAFFIC & PARKING SERVICES – ROAD SAFETY**
Safety Audit Ref: TE/16-528/LT121/ST1
Date: 26th October 2016

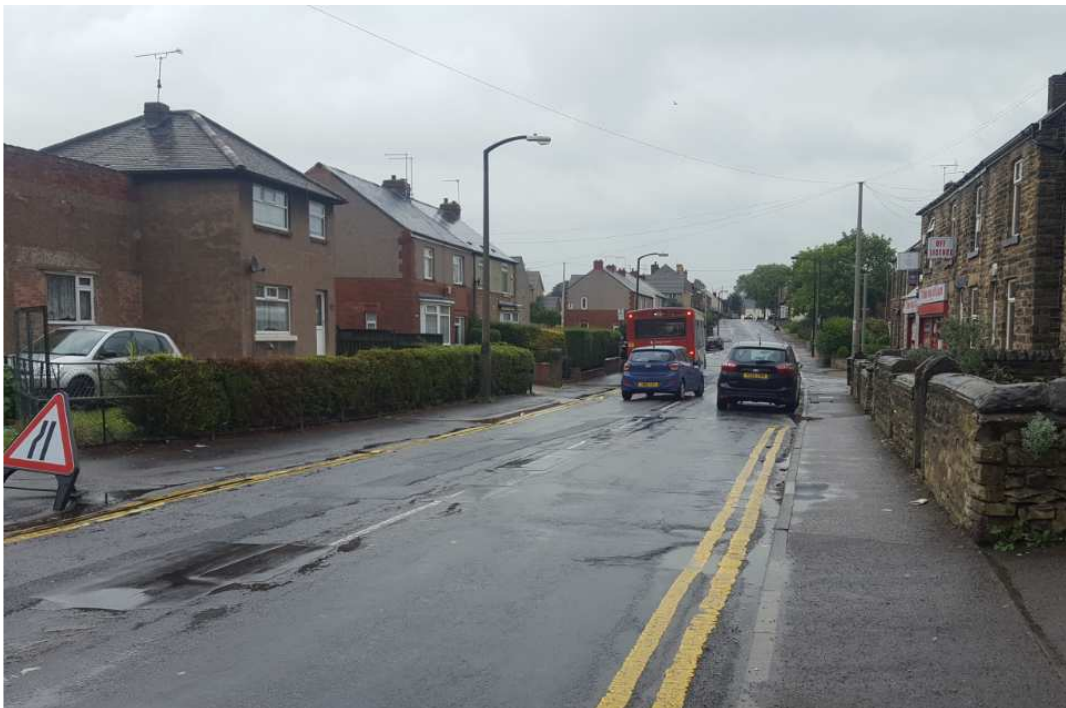
Following the survey, Design Team parked a vehicle in the position where parking would be permitted outside the shop, at the extent of the proposed zig zags. The photo below demonstrates the visibility, which is 50m.

It was noticeable that parking in this area slowed westbound vehicles, in a similar manner to that of a formal priority give way, although speeds have not been taken at that precise point under such a scenario.

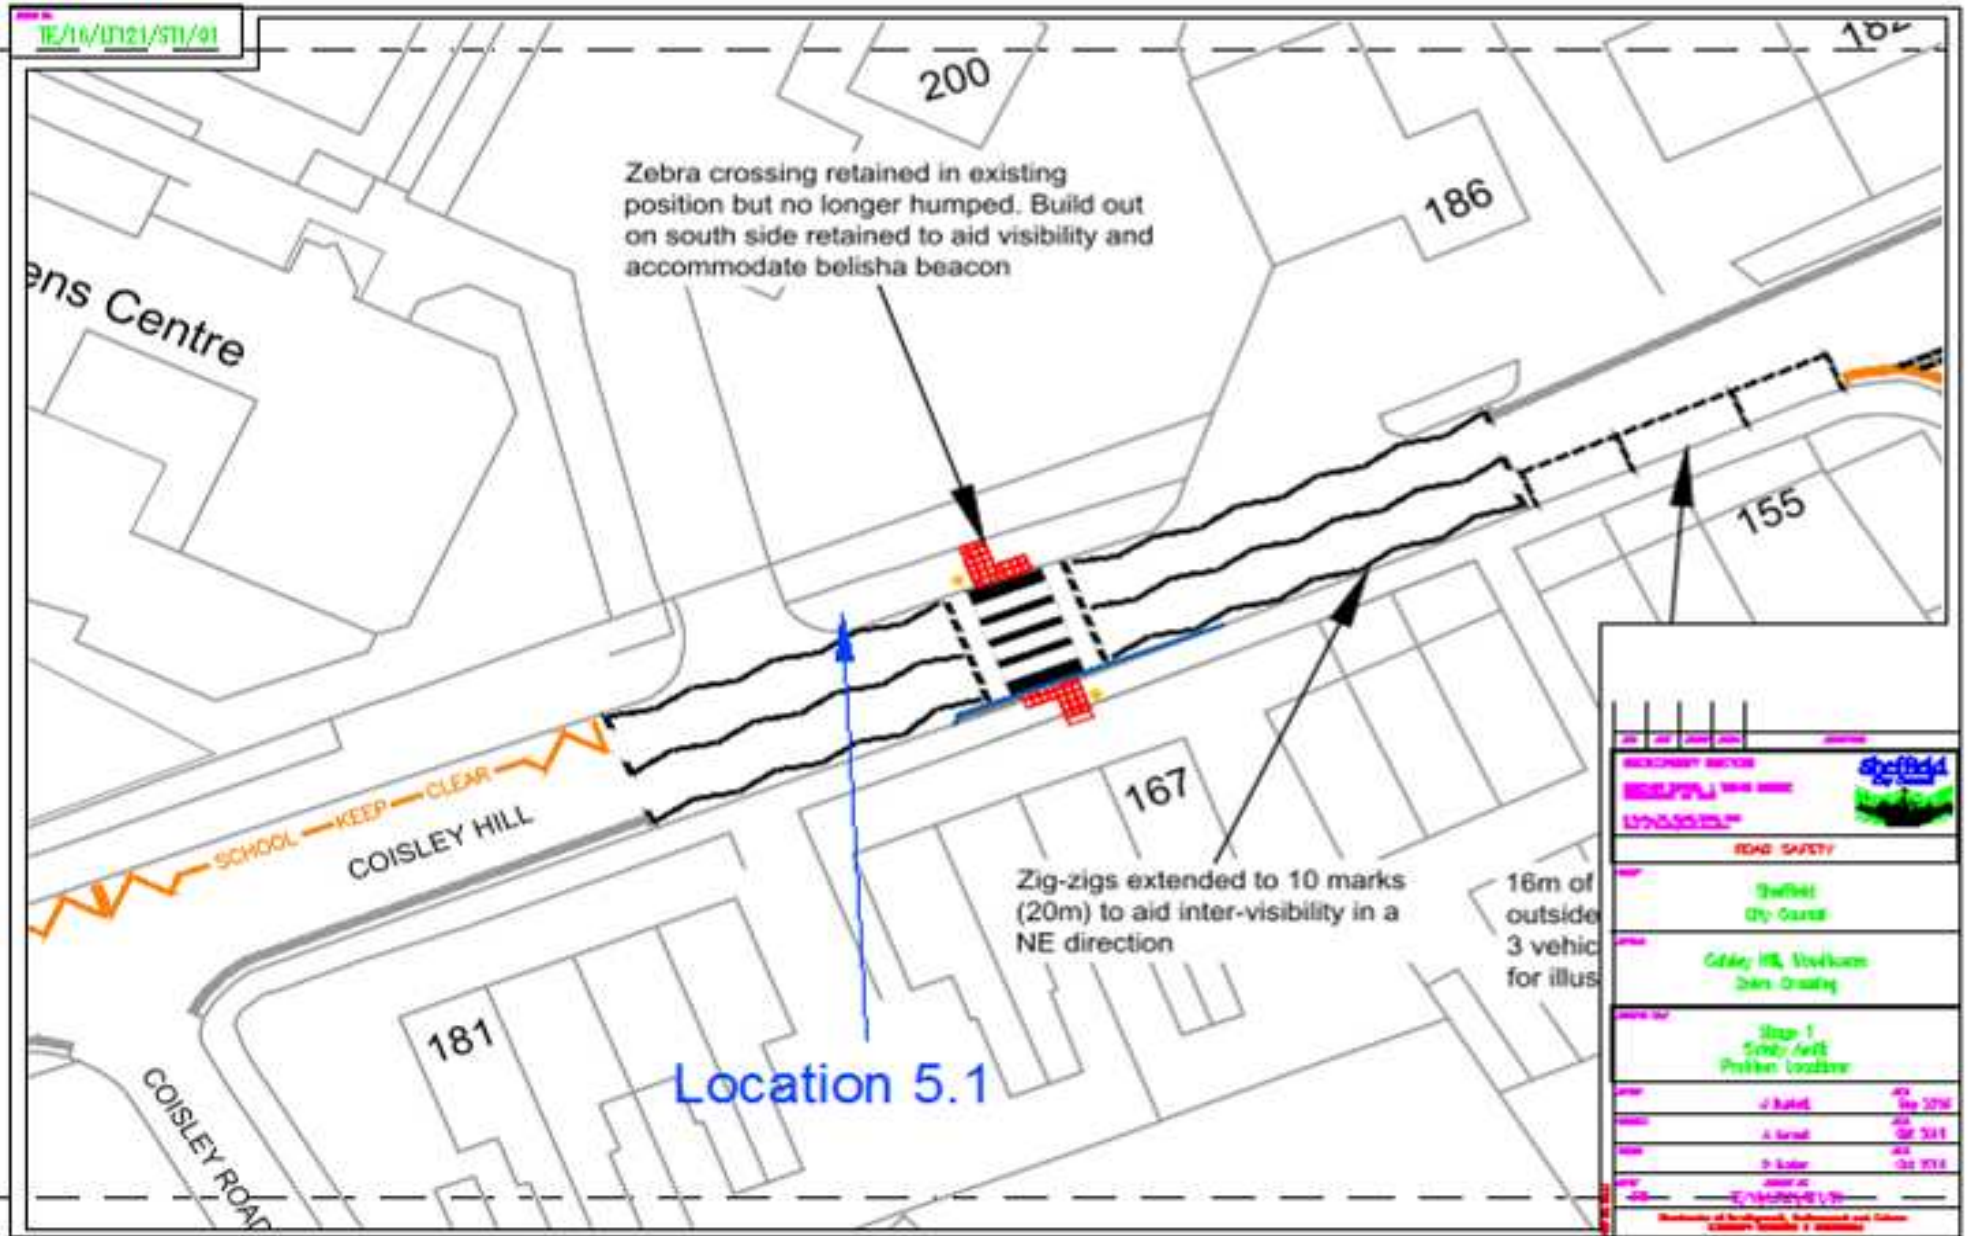
TE/16-528/LT121/ST1/01

Location: Reference 5.1 on Plan TE/16/LT121/ST1/01 at Appendix B – Coisley Hill, northern footway on approach to proposed crossing

Summary: Lamp column in centre of footway likely to impinge drivers' forward views to beacon and/or child pedestrians waiting to cross, with resulting increased risk of pedestrian collisions

There is a lamp column in the centre of the footway in the above location, approximately 5m in advance of the proposed crossing location. The lamp column is relatively wide (an old concrete column), and could under certain conditions impinge upon drivers' forward views to the beacon and pole. This could reduce driver anticipation of the crossing and so increase reaction times, with a resulting increased risk of collisions with pedestrians.

The column could also adversely affect views to child pedestrians under some conditions.

It is furthermore noted that the column is positioned in the centre of the footway in a location where pedestrian volumes will be high at times (school changeover times), and therefore presents an unnecessary obstruction.

Relocate the column to the rear of the footway.
