Appendix C : Objection

Appeal against Tree Preservation Order No. 445

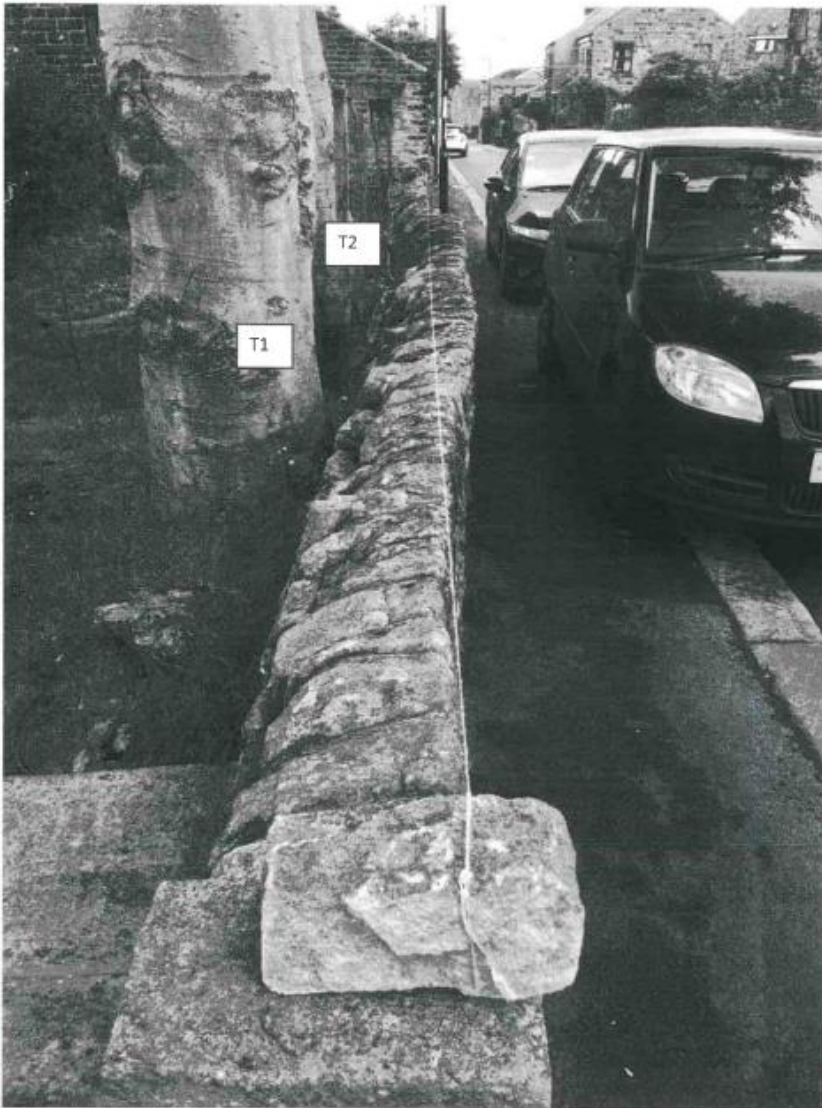
As can be seen in Figure 1, the section next to the trees is now well forward of the original wall line. At the worst point (tree T2 on your drawing No. A4/UED/808/445) the top of the wall has been pushed approximately 10 inches forward (see Figure 2).

Figure 1 Wall position looking south along Middle Lane

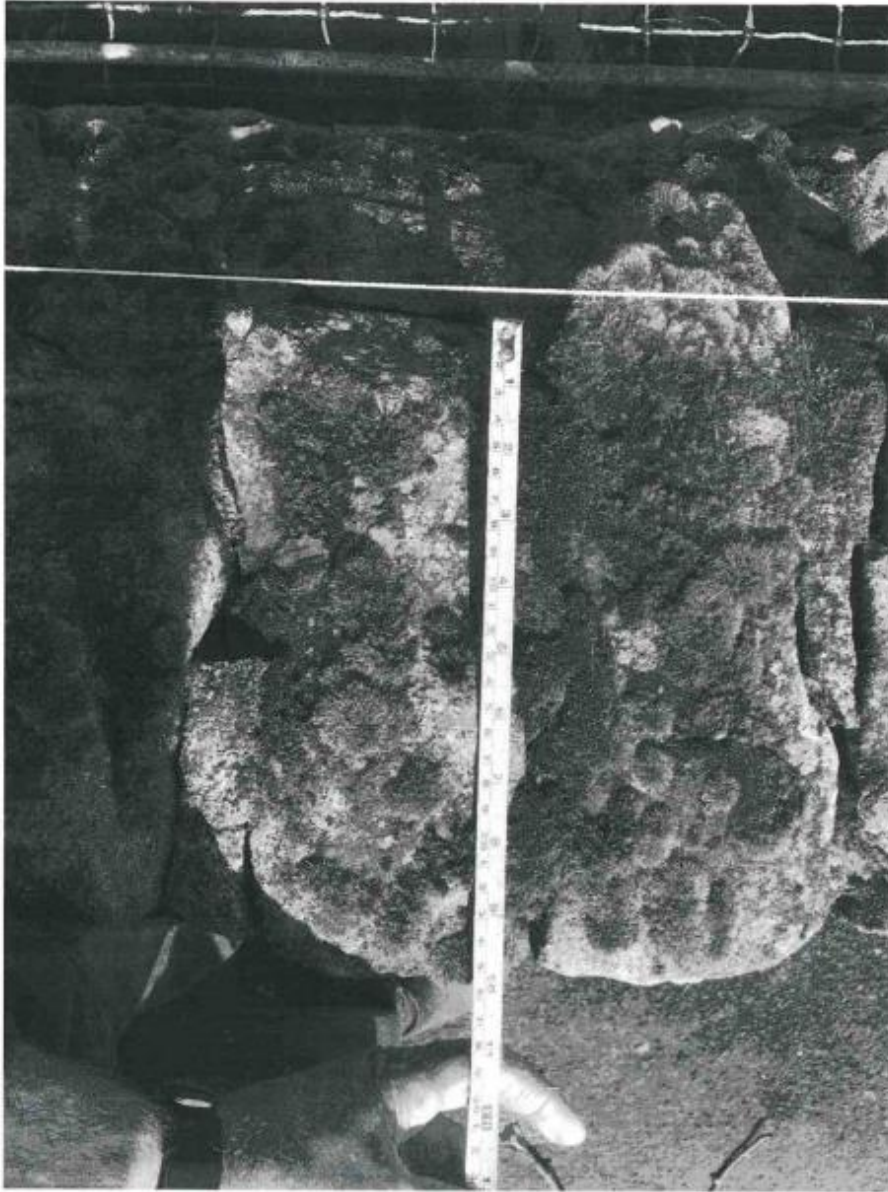
Figure 2 Measurement of wall position relative to original wall line
