Sheffield PFI Performance Update

21st December 2022

Presentation Contents

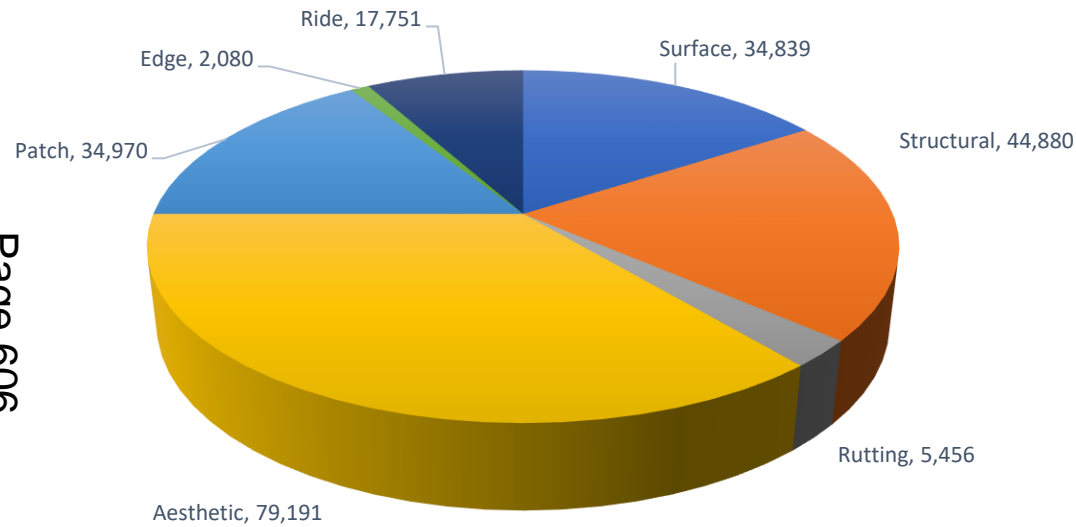
Carriageways Defects Mar 31st 2022 - c220,000 sqm

- Outstanding failed sections represents circa 2% of total network;
- All the above failed sections are included in the Improvement Plan with small number of exceptions agreed with SCC;
- Due to previous whole street approach, Sheffield network has had circa 1 Million square metres more treatment than contract failed sections;
- Sheffield network is of a significantly better standard than most other local authorities due to the initial capital investment and the ongoing high level of maintenance required to achieve contract compliance.

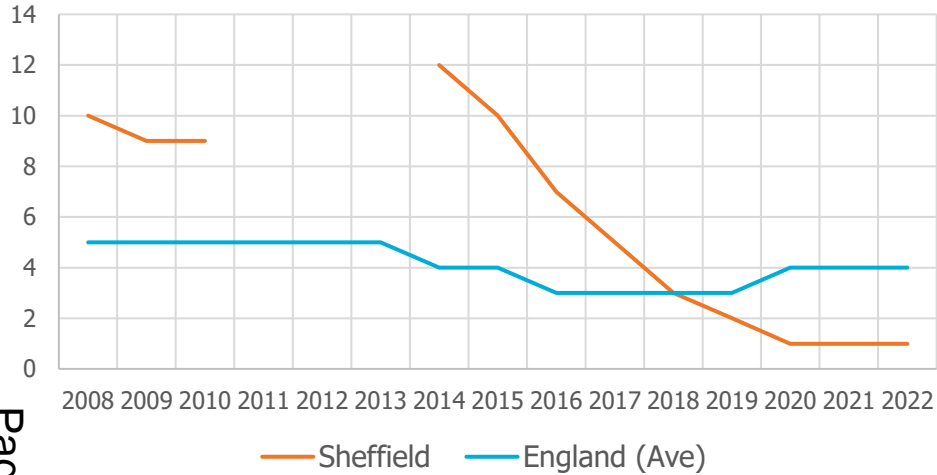
A Roads

- Department of Transport condition data for Sheffield network compared with the National average;
- Left hand scale on graphs represents percentage of roads where treatment should be considered;

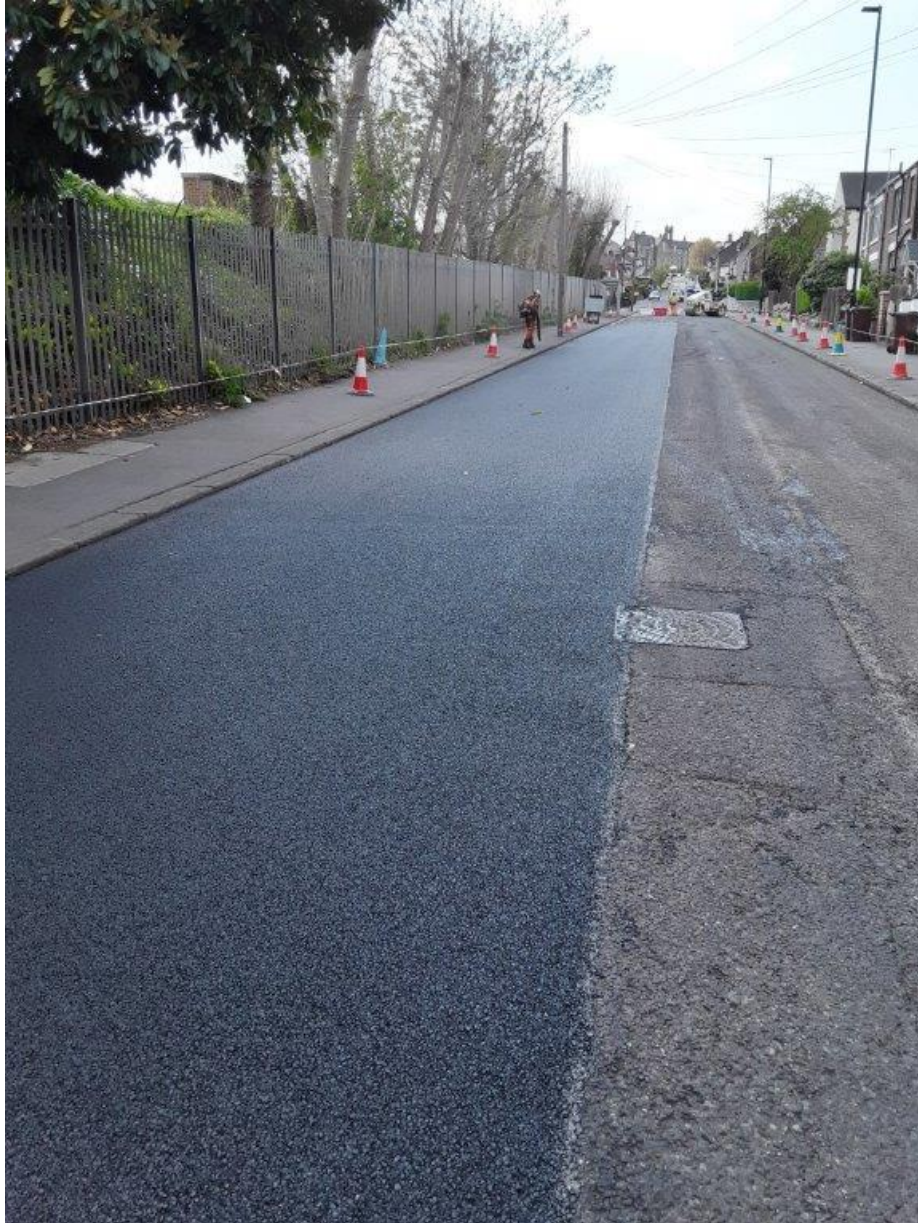
- Heely Bank Road – Treatment to one half of carriageway due to failed section data. Other half shows visible defects but does not trigger contract failed section.
- Surveyed: 19.12.21
- Surfaced: 29.04.22

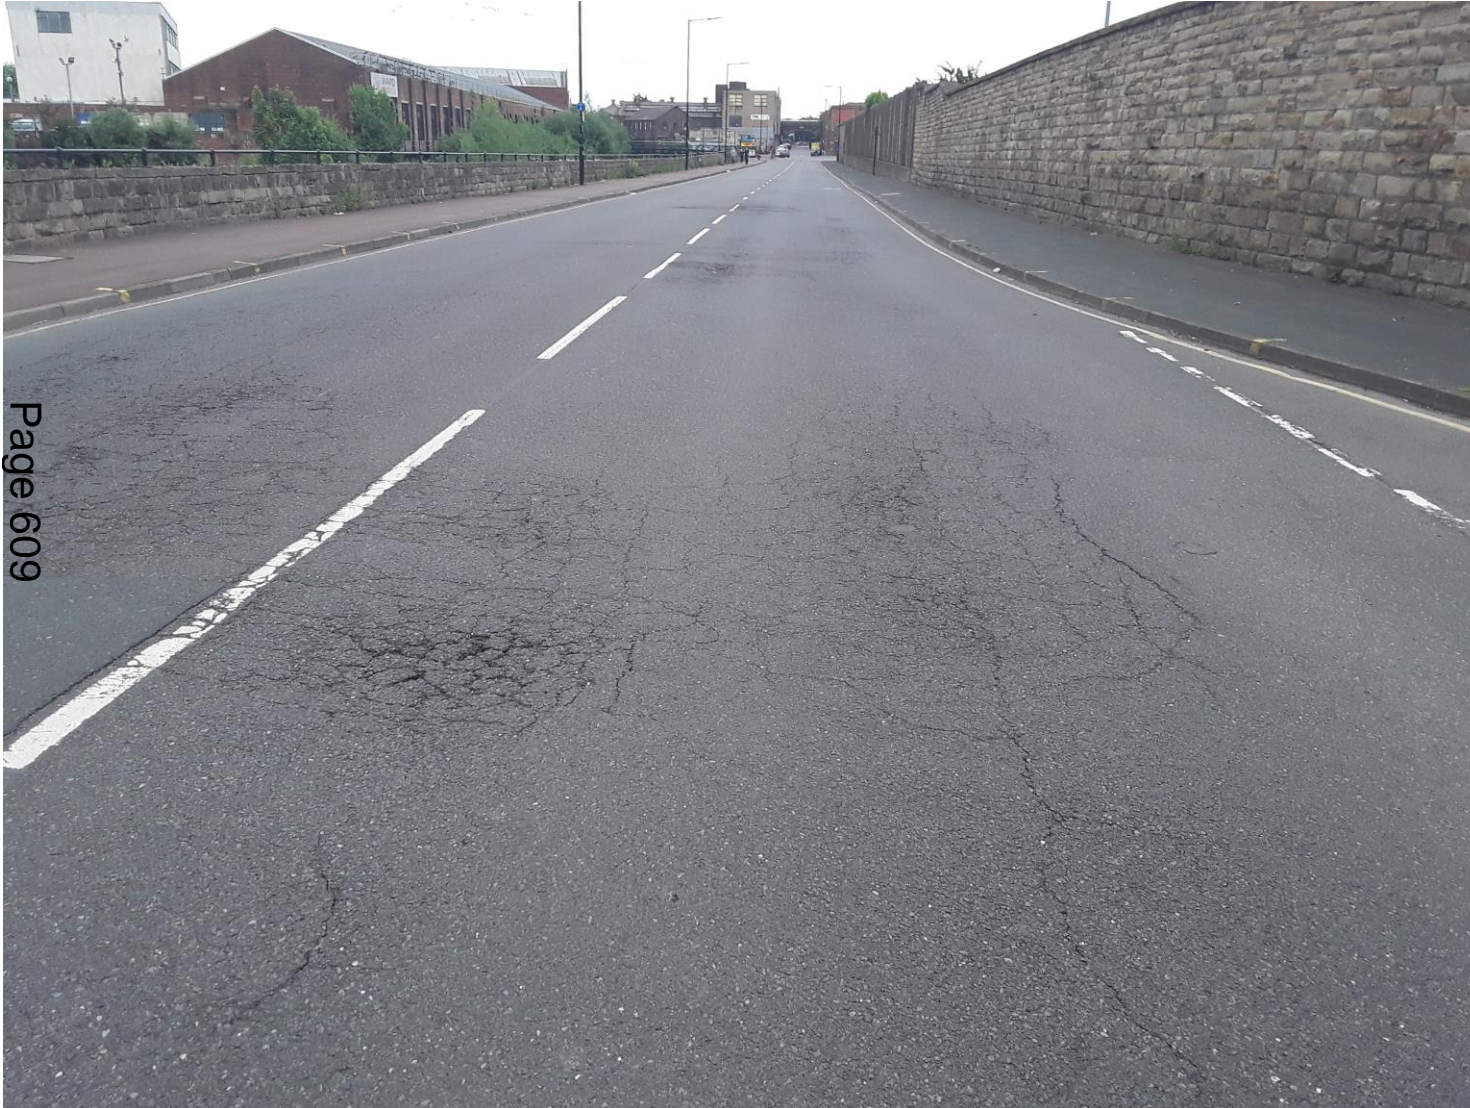
- Effingham Street – Structural failure to right hand carriageway only, left carriageway physically failing but not in failed data.
- Surveyed – 27/6/20
- Surfaced – 26/9/22

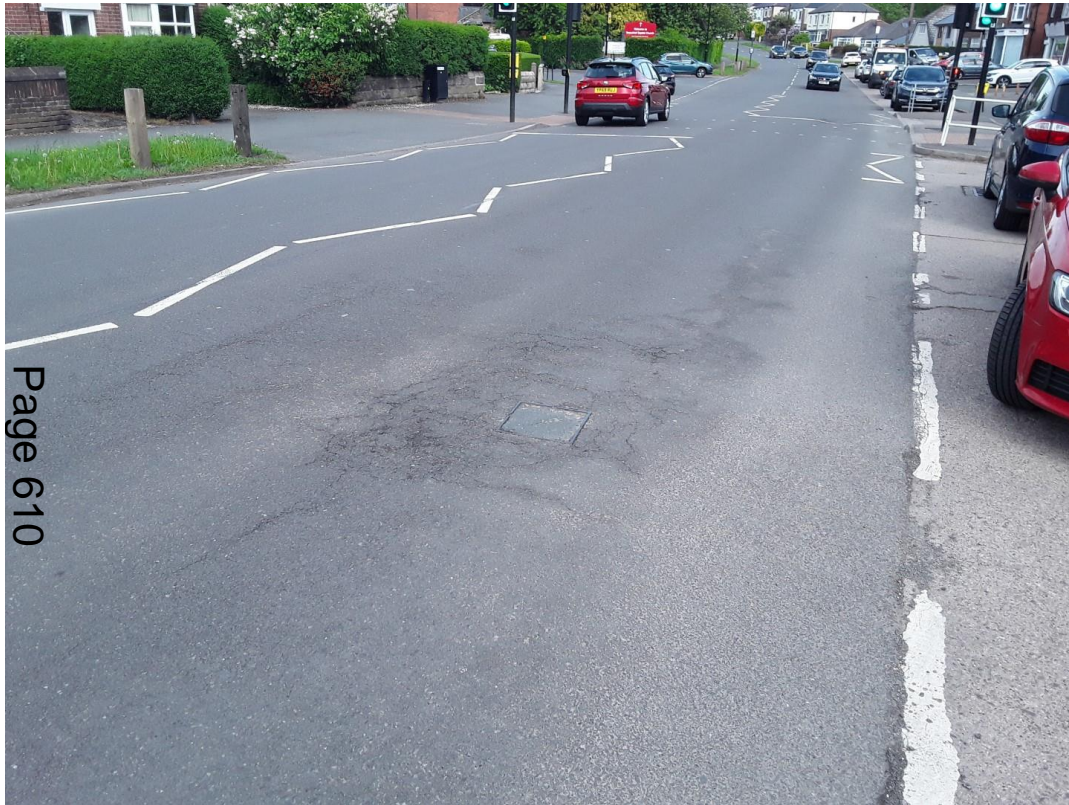
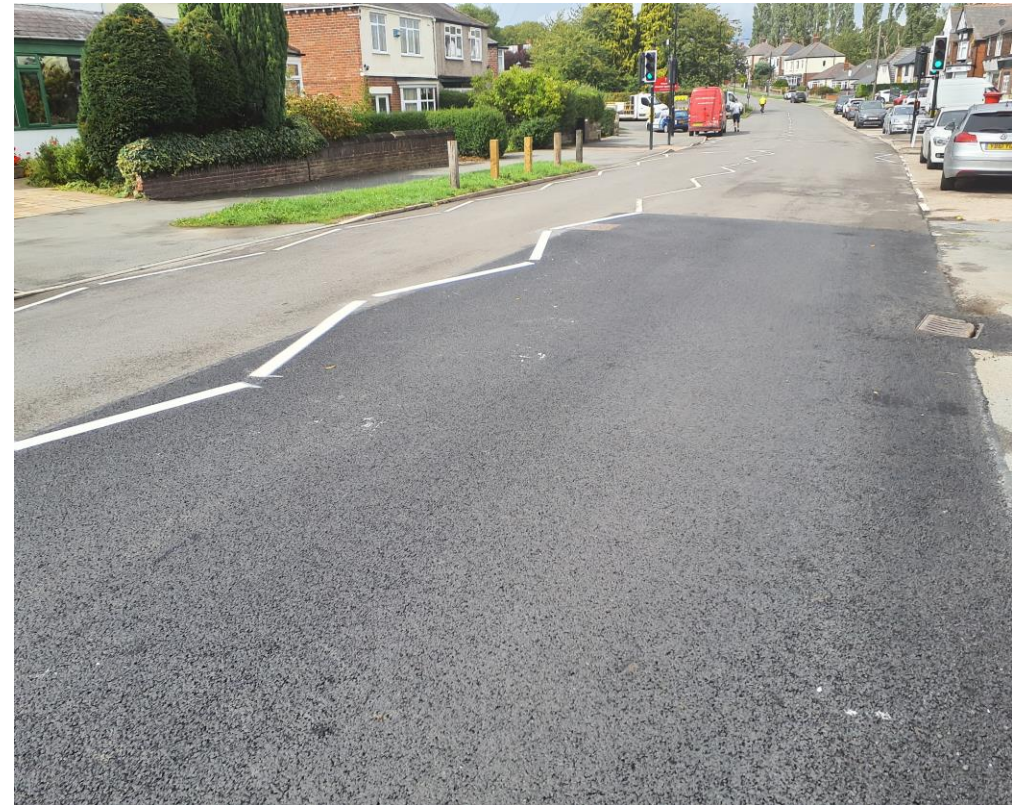
- Hutcliffe Wood Road – Structural failure to Right carriageway only, left carriageway showing elements of deterioration but not in failed data.
- Surveyed – 31/7/21
- Surfaced – 25/8/22

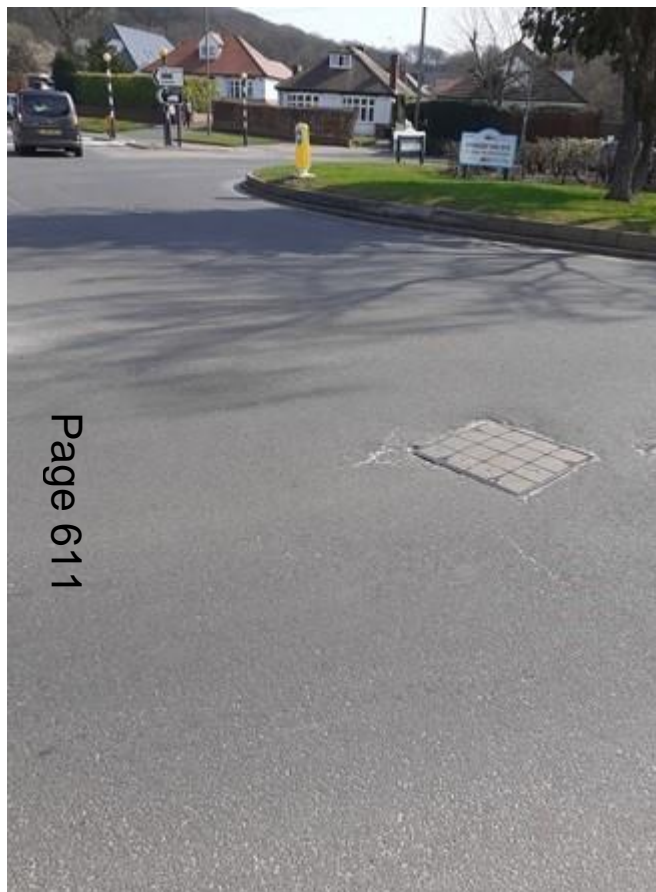
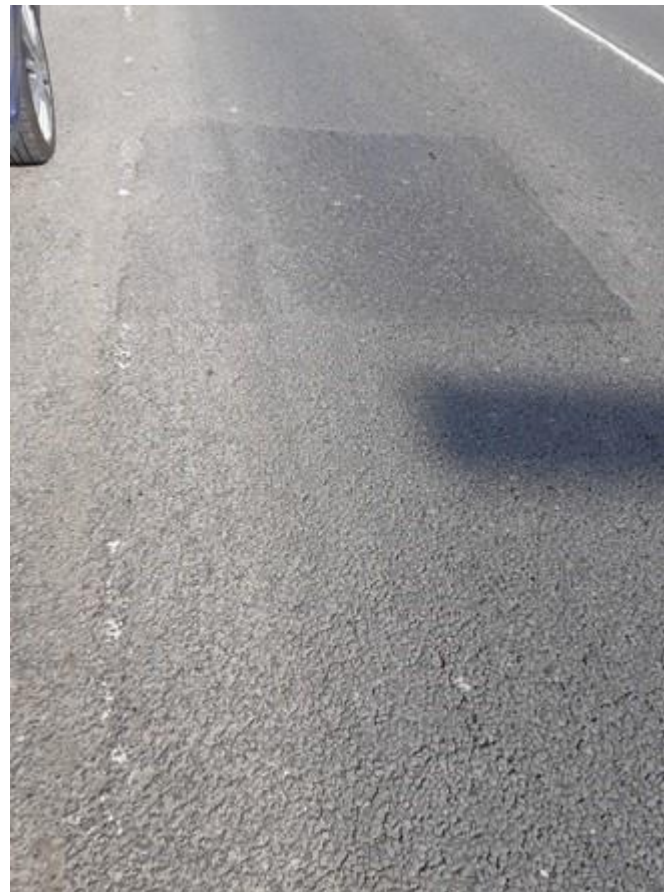
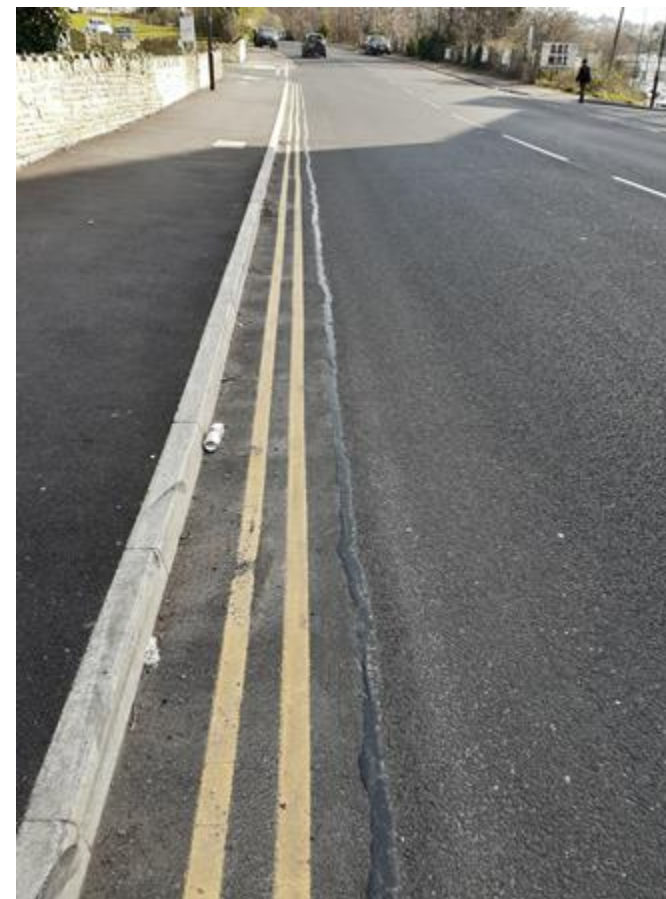
5. Lifecycle Carriageway Examples – Agreed Deferrals

Ride Survey – Measure of surface deformation - Often invisible and triggered by tight radii giving false readings

Patch – Fail highlights the presence of a patch below contractual size (often from statutory undertakers) but in acceptable condition

Edge – edge failure – often highlights an unrestrained edge or work undertaken by third party but in acceptable condition

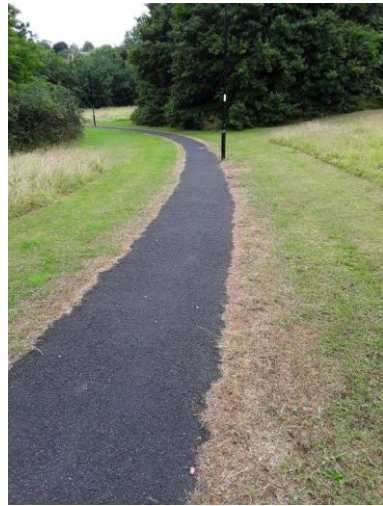
Drakehouse Lane –

Aesthetic failure due to visible aggregate loss and requires micro-surfacing treatment

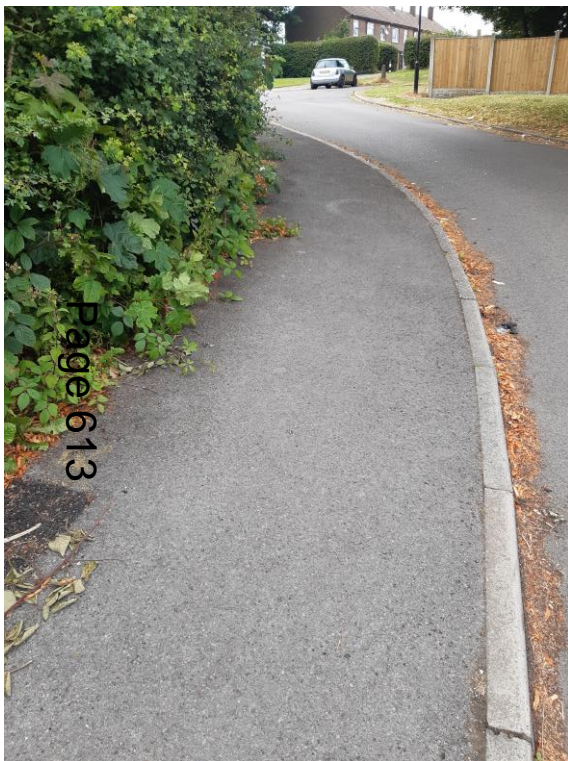
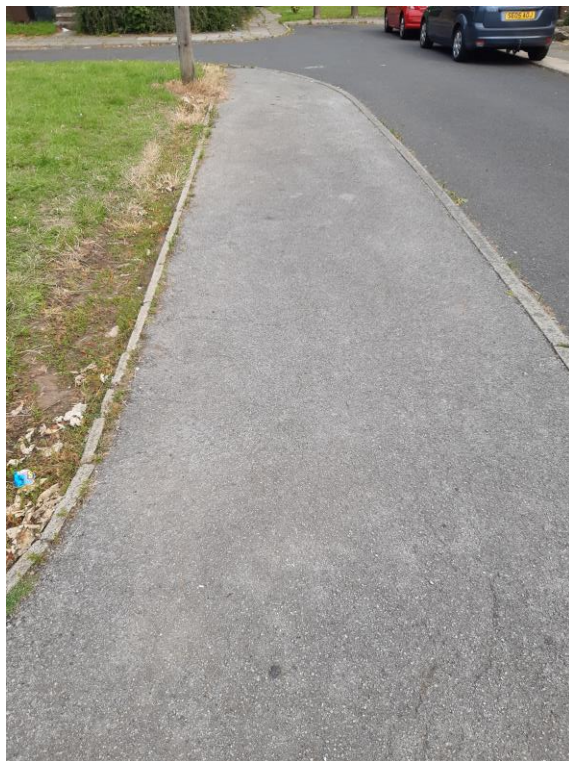
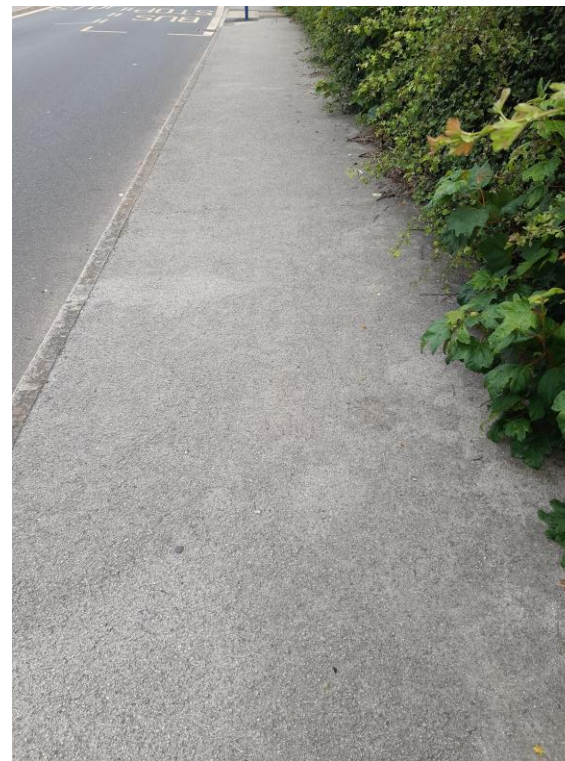
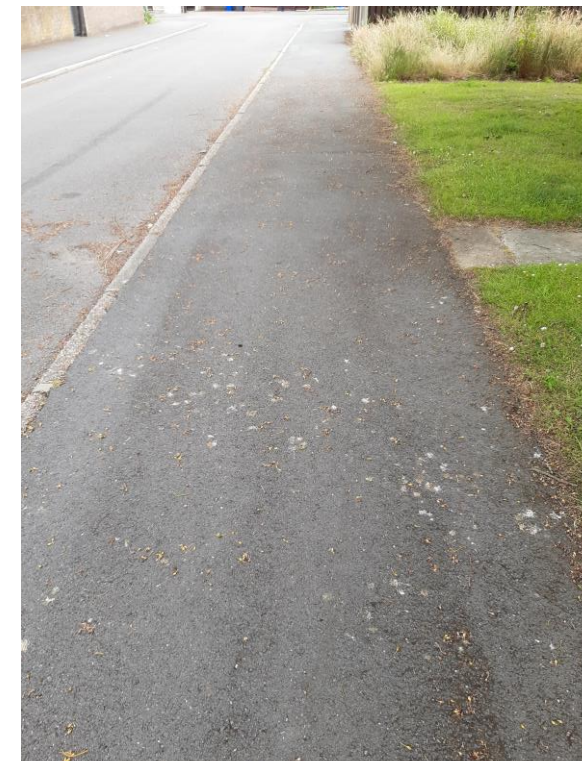
Aesthetic failure due to visible moss, grass or overgrown vegetation and requires cleansing treatment

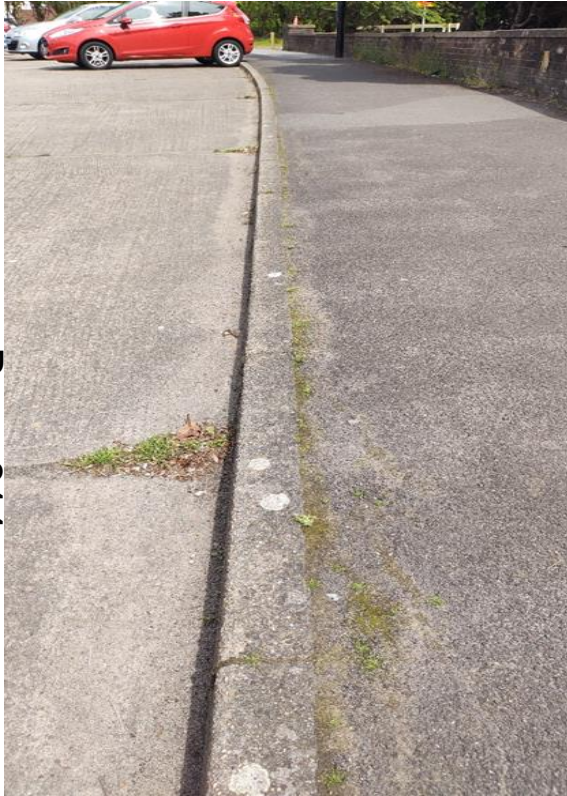
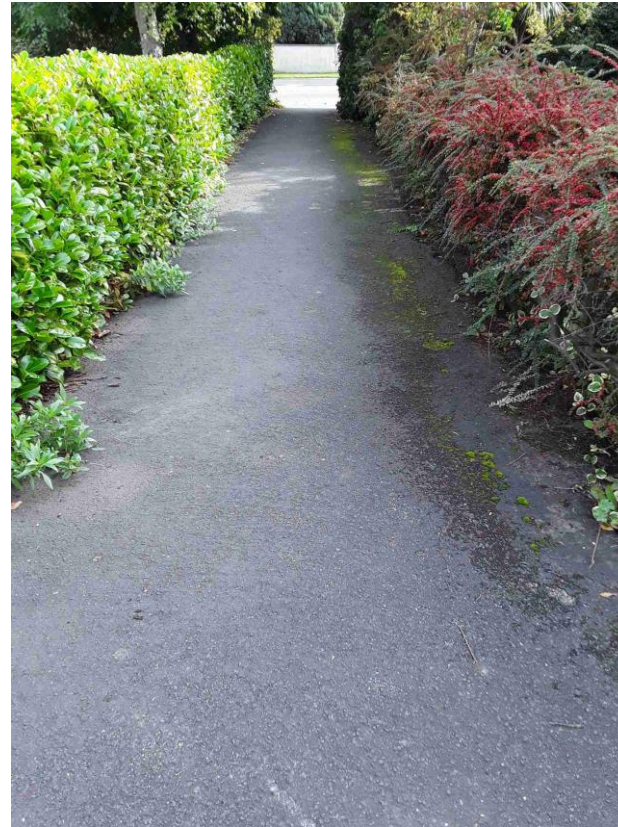
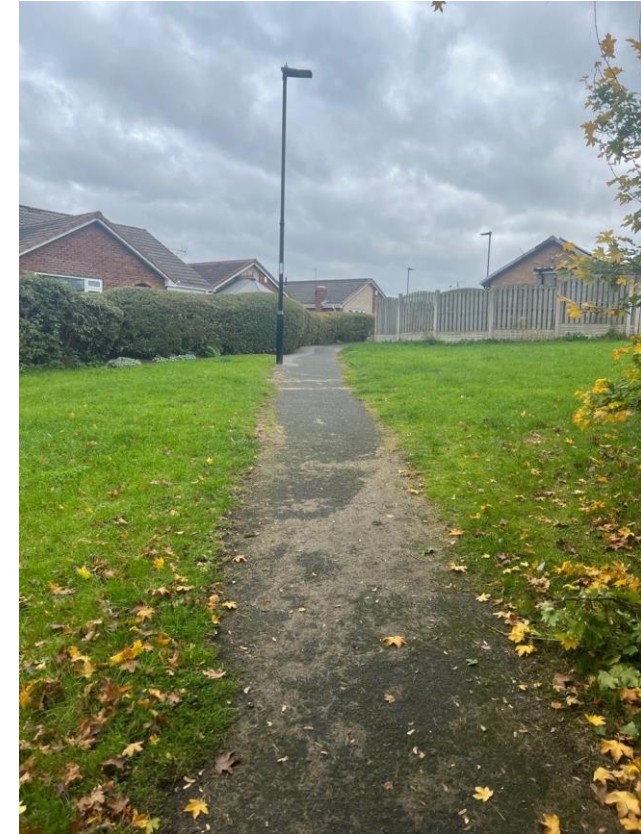
- Approximately 50% of all square area related to cleansing remedies on the footway network which required sweeping to become compliant.
- The scoring mechanism triggered significantly larger failed areas than actual area requiring works
