John Lewis Building Condition Assessment

Sheffield City Council

Summary Report

November 2021 Rev A

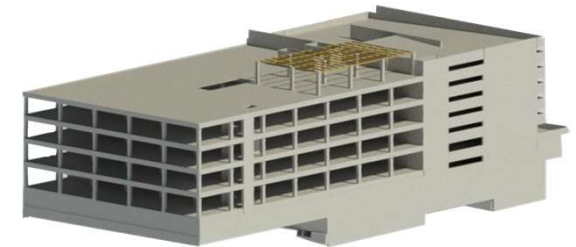
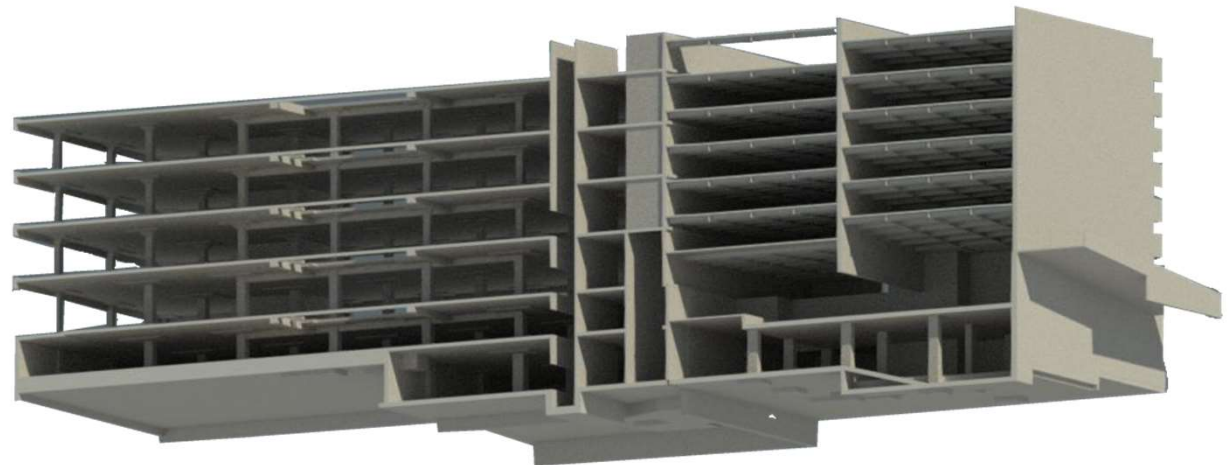
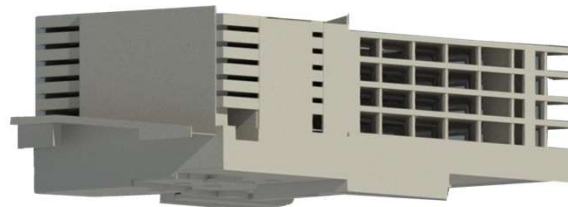
The concrete frame of the main store could not be immediately inspected due to the presence of the interior fit out and the extensive asbestos issues in the finishes. Therefore the condition of the structure of the main store is difficult to assess due to restricted access to the site and existing finishes/coverings.

However, the limited exposed areas of structure witnessed during our inspections are in a reasonable condition, and we would expect the structure to be reusable as part of an extensive refurbishment of the building –noting the limited nature of the visual survey. Further intrusive investigations would be needed if this option is to be pursued.

There will inevitably be some issues with this frame, particularly on the roof level due to failures in the roof finishes and having RWP's embedded in some of the columns.

Once the building is stripped out and available for inspection then the concrete frame can be closely inspected for any signs of deterioration and damage.

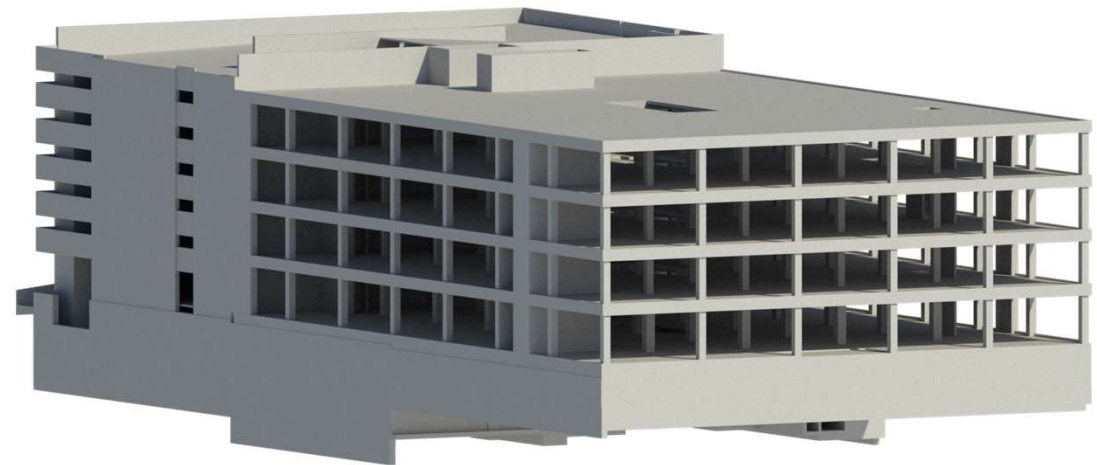
The car park is in a much poorer condition than the main store and there are numerous elements of cracking and spalling of the concrete. The steel beams have areas of corrosion that has removed the corrosion protection and also the intumescent paint that provides the fire protection to the structure.

The de-icing salts used over the years have corroded the concrete structure. The chloride ingress has resulted in significant areas of deterioration. Significant repair works and maintenance would be required over the next 25 years

The car park is not in good condition and would require significant repair and ongoing maintenance over a 25year period. In conjunction with reducing car parking demand with John Lewis vacating, we would recommend that serious consideration is given to demolition of the car park in any redevelopment option.

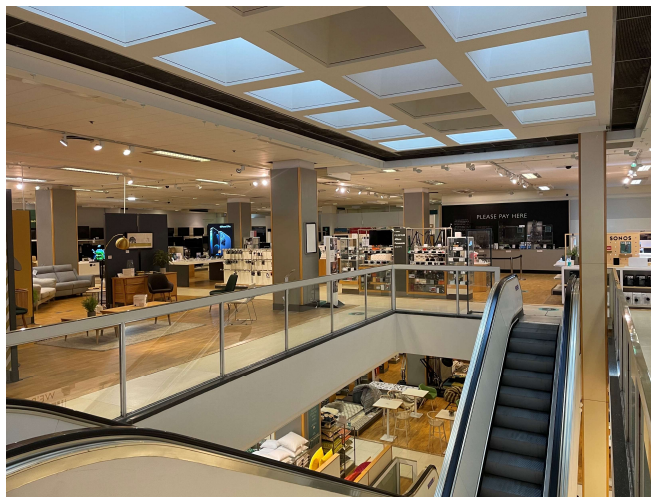
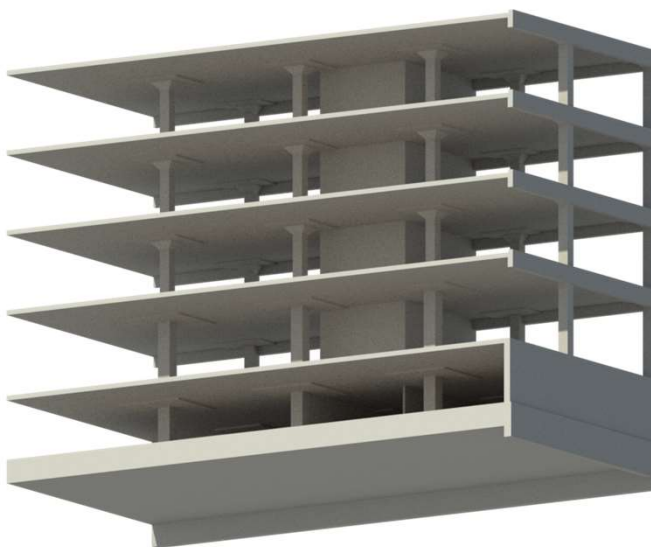
The building is not fully protected by an automatic fire detection and alarm system, which would be normal current practice for any similarly sized building. A sprinkler system exists, which is fed directly from the mains water system (with a dedicated booster pump); this would not be compliant with current practice.

The lighting system is inefficient and no longer suitable for continued use, even in a retail situation.

It is therefore recommended that any refurbishment or repurposing of the building includes a full strip out of all ceilings, non-structural partitions, services distribution (wiring containment, ductwork, pipework), MEP plant and equipment, taking care to remove and dispose of all asbestos containing materials (ACMs). This will create a clear canvas for new, efficient systems to suit the new purpose.

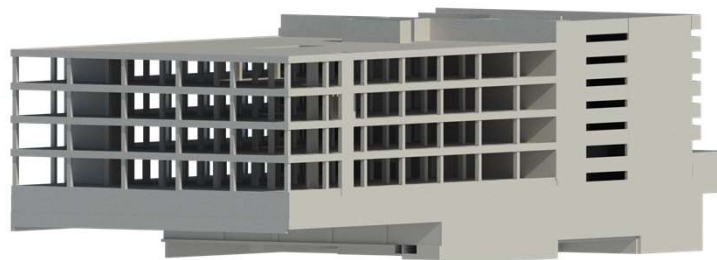
Structural beams were observed to have cementitious/vermiculite type fire protection boards of varying thickness in the back of house and plant areas. It would be reasonable to assume that this would be likely to provide at least 60 minutes fire resistance. However, areas were observed where this protection was either damaged or missing.

- The level of fire protection to the building structure is unknown. In some areas damage has occurred to the fire protection of the structure and needs remediation.

- The extent of required compartmentation and fire resisting enclosures should be defined, and all penetrations should be made good.
- The car park appears to have no fire alarm installed.
