CITY CENTRE, SOUTH & EAST PLANNING AND HIGHWAYS COMMITTEE 17 December 2012

ENFORCEMENT REPORT

UNAUTHORISED FRONT DORMER WINDOW AT 79 BARBER ROAD

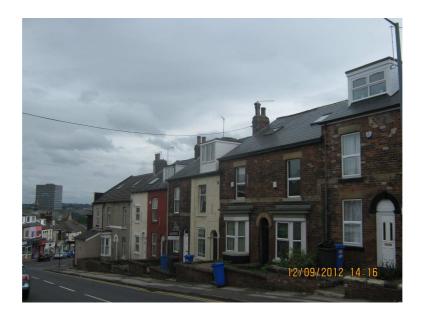
Photograph 1 67-85 Barber Road

- 2.1 79 Barber Road forms part of a terrace of brick built, slate roofed, two storey dwelling houses (built approx 1890 1910), with a variety of roof lights and dormer windows having been added to their front roof slopes at various times in the past (See photograph 1).

- 2.5 In spite of this, the owner has not applied for planning permission for a revised dormer window.
- ASSESSMENT OF BREACH OF CONTROL
- 3.1 The dormer window, which covers a significant proportion of the property's front roof slope, is not in scale and character with both the building to which it belongs and that of neighbouring properties; and, therefore, is considered to be contrary to UDP policies BE5 (c), H14 (a) and SPD Guideline DHE5.(See photograph 1).

- 3.2 The dormer, as constructed, is excessively large, dominates both the roof slope and street scene, and, due to its design and materials, is entirely out of character with the property on which it is displayed.

- 3.3 Although other dormer windows exist within the street scene, this particular dormer is considerably larger, is not set back from the eaves of the main property, and as such is much more prominent and harmful to the street scene. The large dormer to the right hand side of photograph 1 is unfortunately more than four years old, so immune from enforcement action. However, the smaller dormer, lower down the hill has planning permission but has been constructed in the wrong materials. Officers are pursuing this matter with the owner to ensure the dormer is clad in tiles to match those of the main roof, which will significantly improve its appearance.

- 4.2 Section 172 of the Act provides for the service of an enforcement notice (EN). In this case such a notice would require the removal of the dormer window to make good the harm caused by the unauthorised development.

- 7.1 That the Director of Development Services or Head of Planning be authorised to take any appropriate action including, if necessary, enforcement action and the institution of legal proceedings to secure the removal of the unauthorised front dormer window at 79 Barber Road.
- 7.2 The Head of Planning is delegated to vary the action authorised in order to achieve the objectives hereby confirmed, including taking action to resolve any associated breaches of planning control.
